Your Inspection Report

650 Arnold Court
Marietta, GA 30063

INSPECTION DATE:
Wednesday, April 21, 2021

RE: Report No. 38925, v.2
650 Arnold Court
Marietta, GA
30063

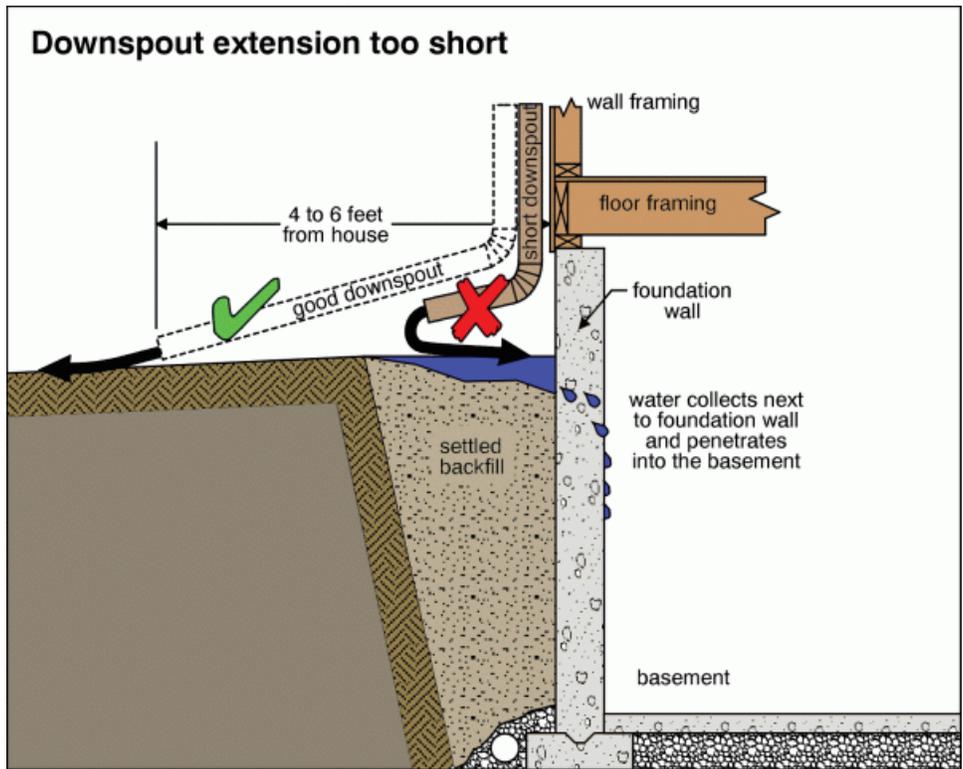
12. Left side

3. Condition: • Discharges Too Close to the Building

Task: Extend downspout termination point at least 6 feet away from building, foundations, footings and slabs.

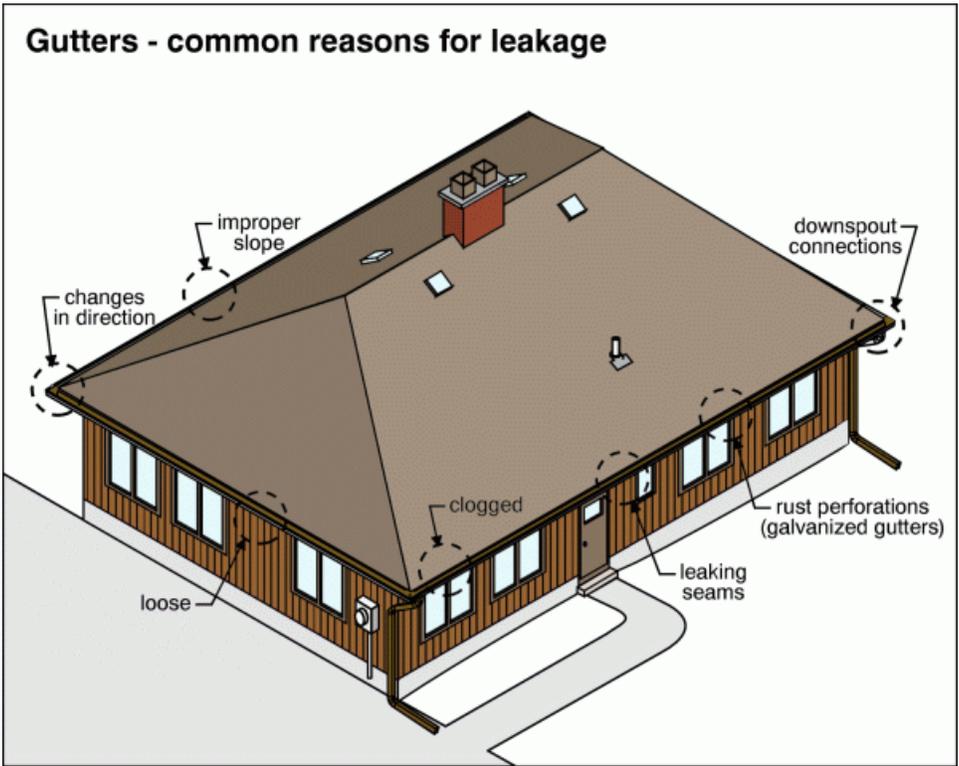
13. Clogged

4. Condition: • Clogged

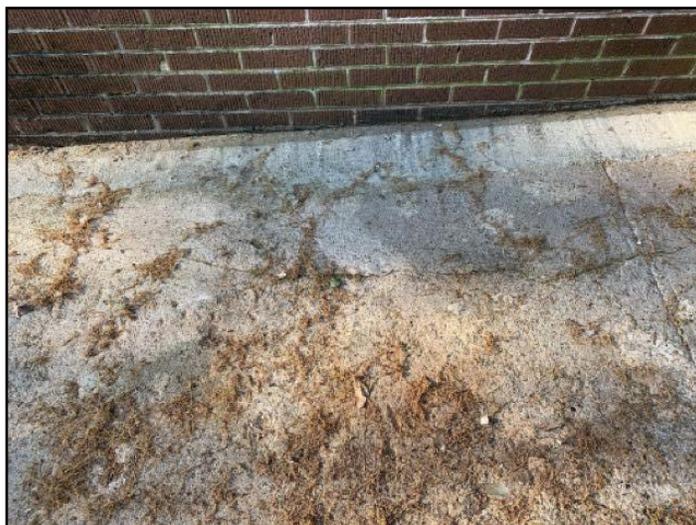
30. Driveway

14. Condition: • Cracked or Damaged Surfaces

Task: Repair As Needed

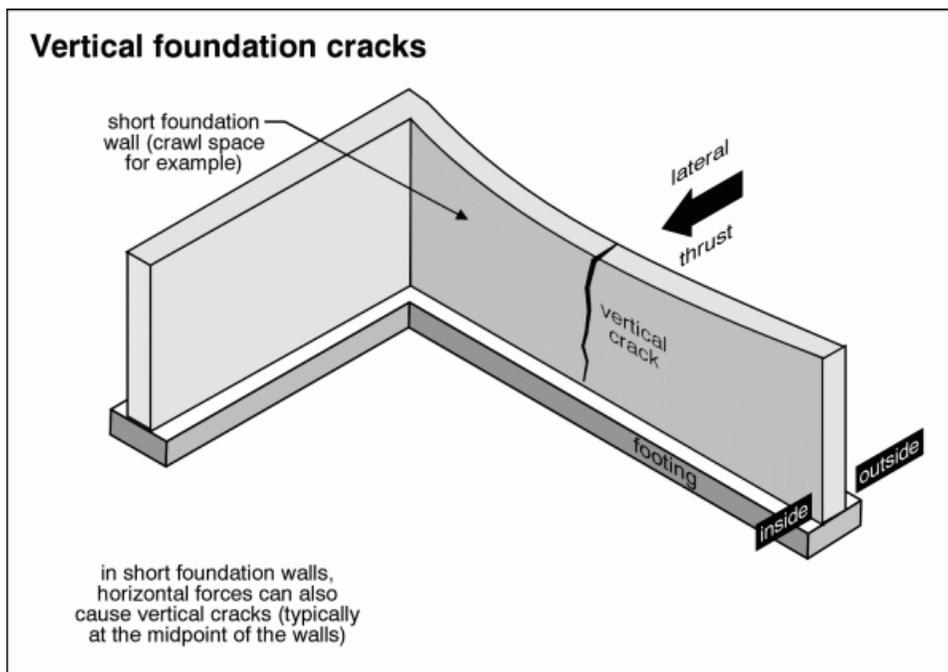
16. Condition: • Cracked

While there are obvious issues with the foundation, an engineer will be required to assess and write a scope of work before any cost estimates can be associated with repair

Task: Structural Engineer or Foundation Expert should evaluate

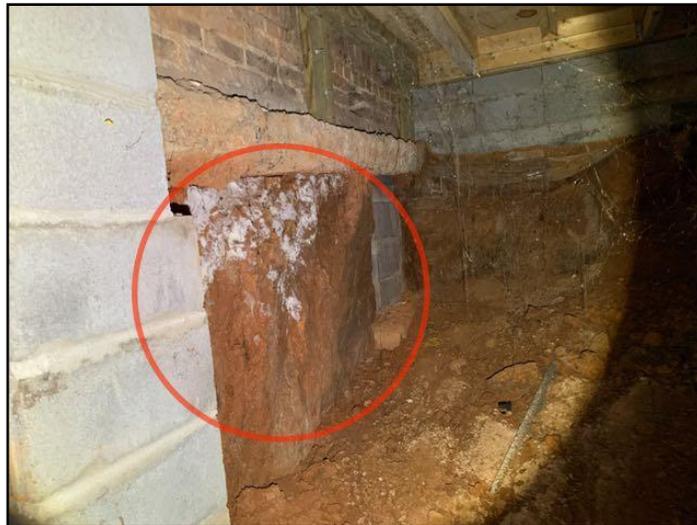
37. Right rear

17. Condition: • Foundation has been under cut

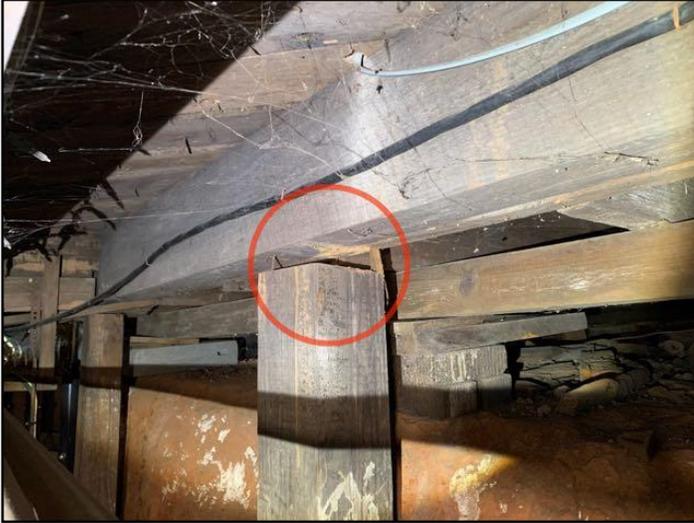
41. Rear

19. Condition: • Rust/Compromised/Damaged

Task: Replace
Time: As Soon As Possible
Cost: \$200 - \$400 Each

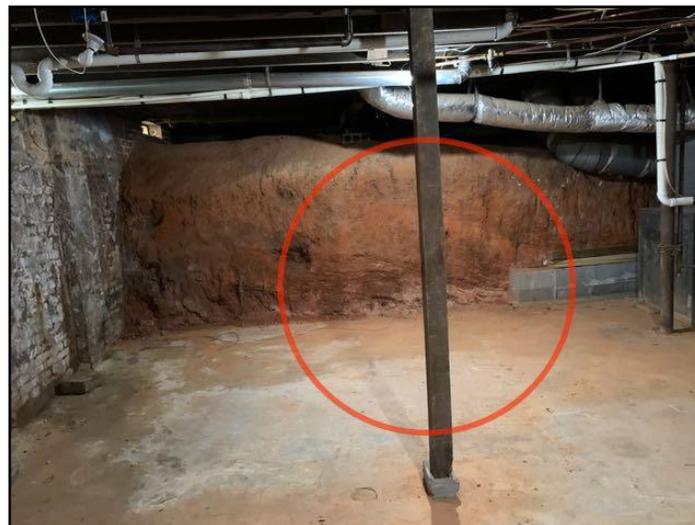
43. Middle

20. Condition: • Column bowing

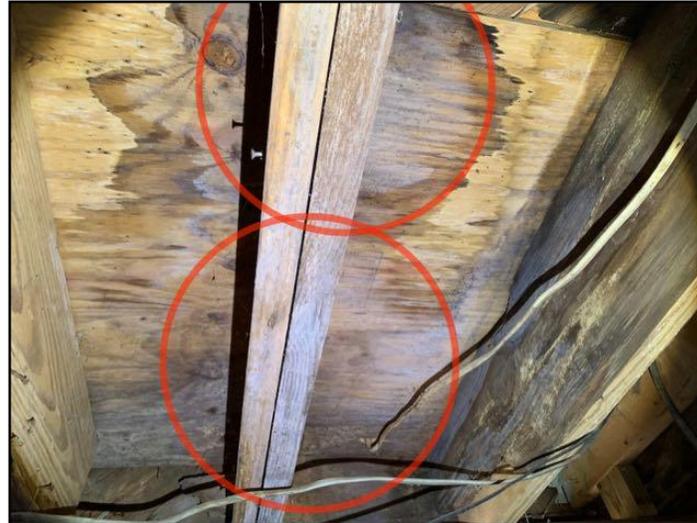
49. Underneath kitchen

23. Condition: • Water stains

Source of water must be identified and corrected before conducting repairs.

Task: Consult with a qualified contractor
Time: As Soon As Possible
Cost: Depends on the preferred remedy of repair

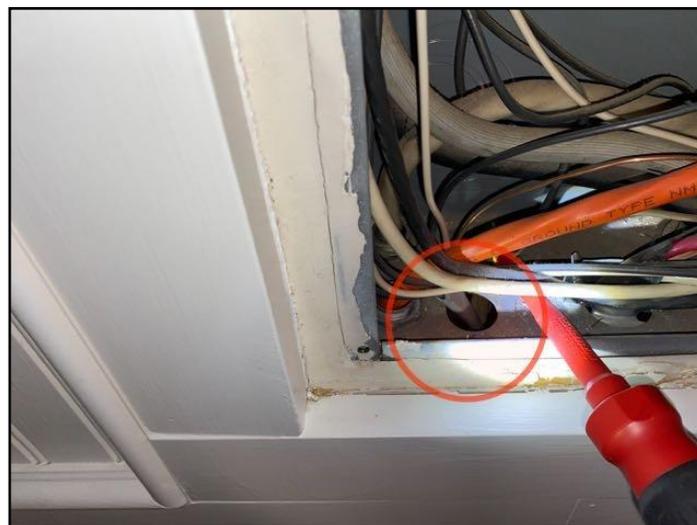
25. Condition: • Not well secured

51. *Not well secured*

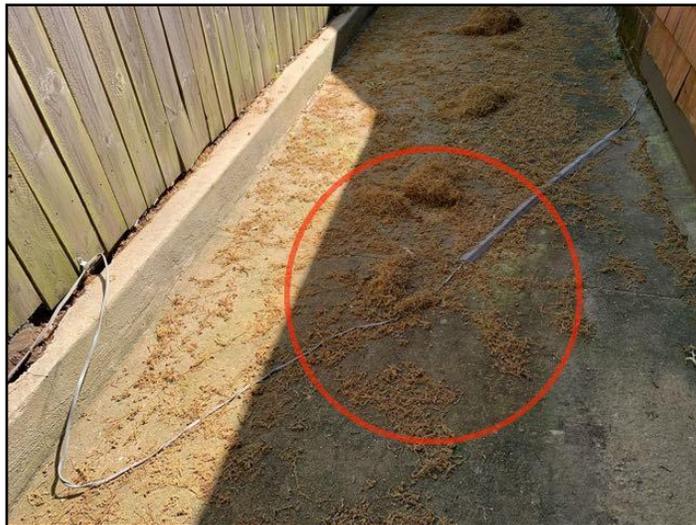
59. Right rear

30. Condition: • Garage feeder wire is run across the ground

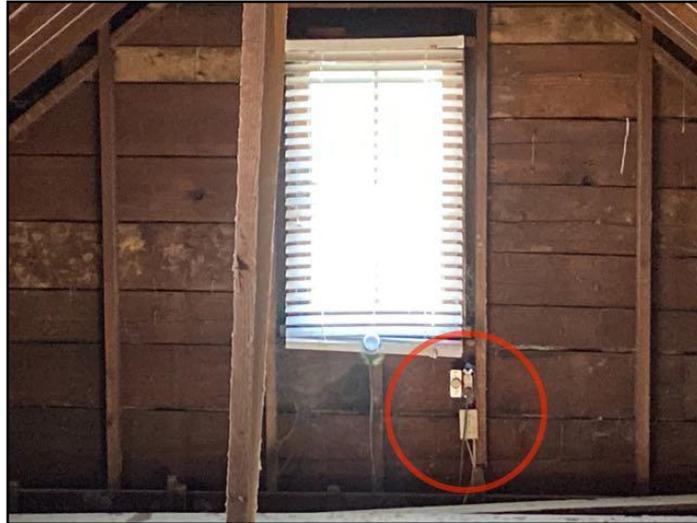
66. Attic

35. Condition: • Loose, missing, broken cover plate

Task: Replace
Time: Immediate
Cost: Minor

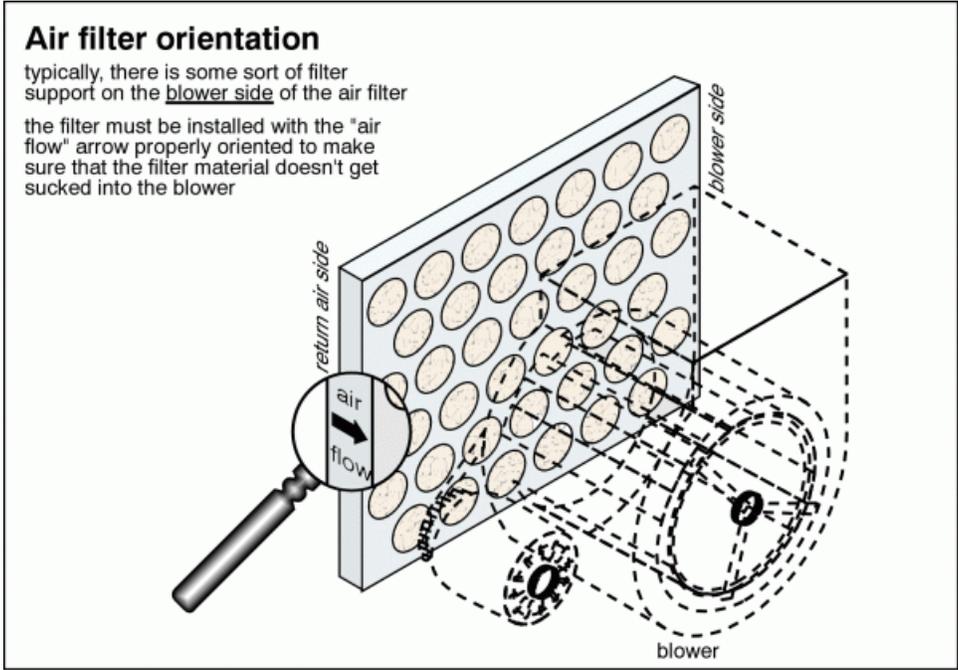
79. At furnace

42. Condition: • Dirty

Task: Replace

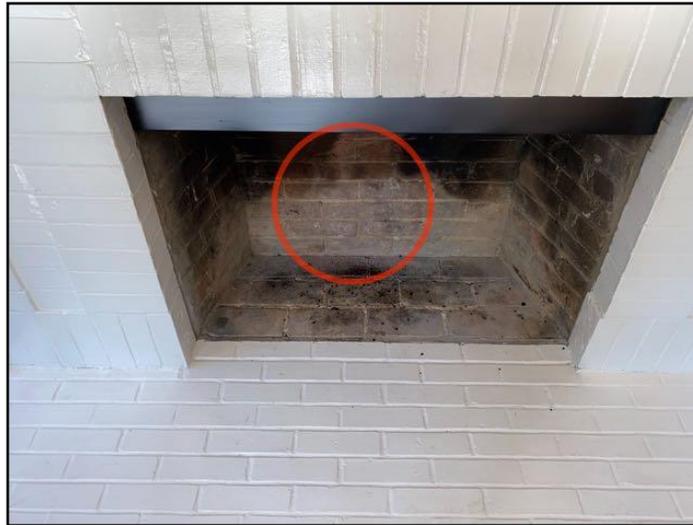
82. Deteriorated, missing or loose masonry or...

Task: Repair

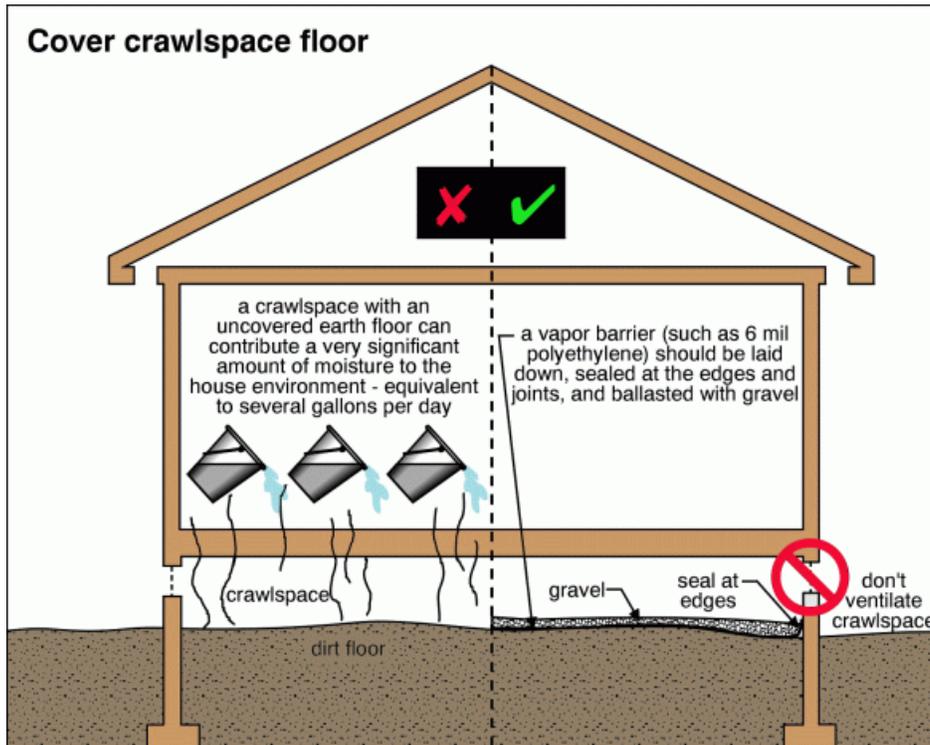
49. Condition: • Vapor barrier poorly or partially installed
Location: Crawlspace
Task: Repair or replace
Time: As Soon As Possible
Cost: Depends on the preferred remedy of repair

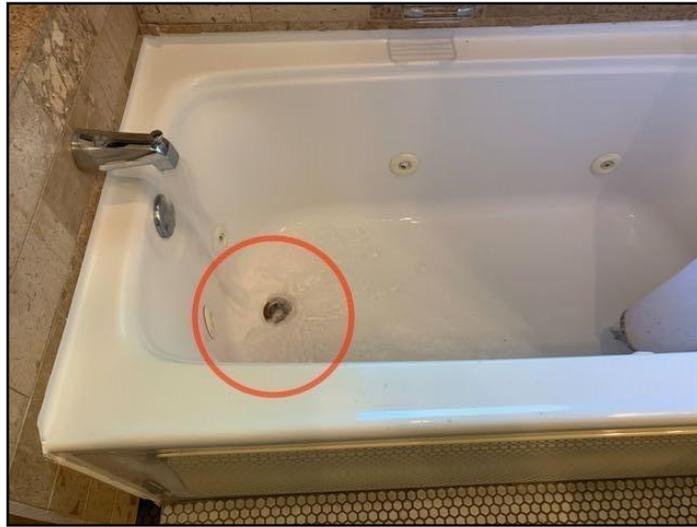
98. Hall bathroom

57. Condition: • Drain stop missing

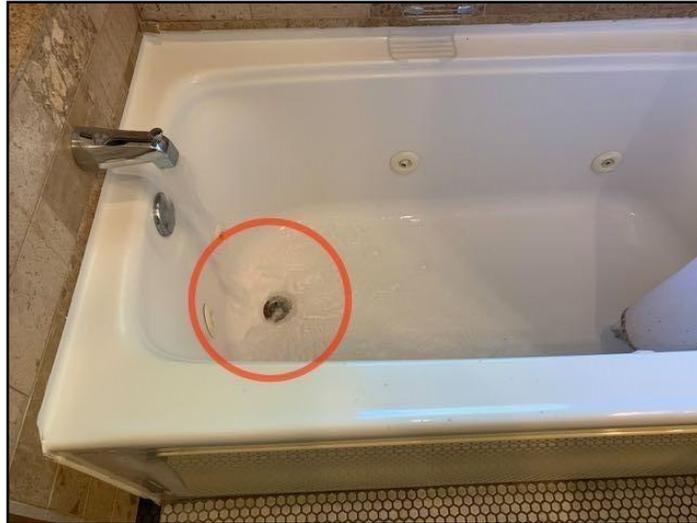
105. Whirlpool bath

- Whirlpool bath
Drain stop missing

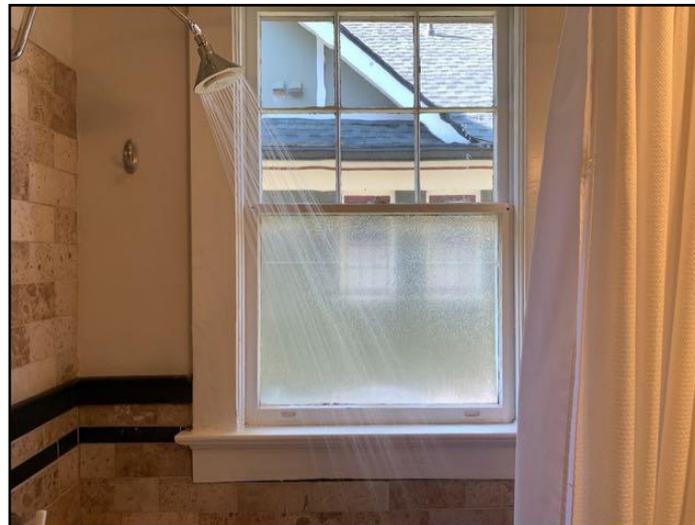
113. Hall bathroom

65. Condition: • Safety Glass Not Installed

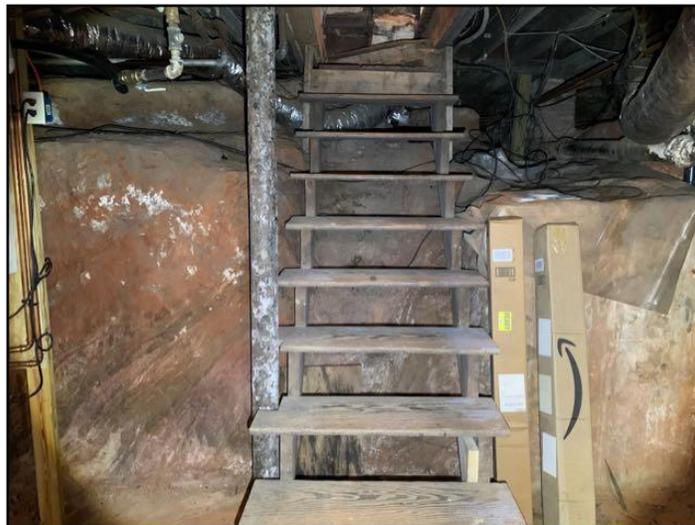
121. Basement stairs

71. Condition: • Poorly supported

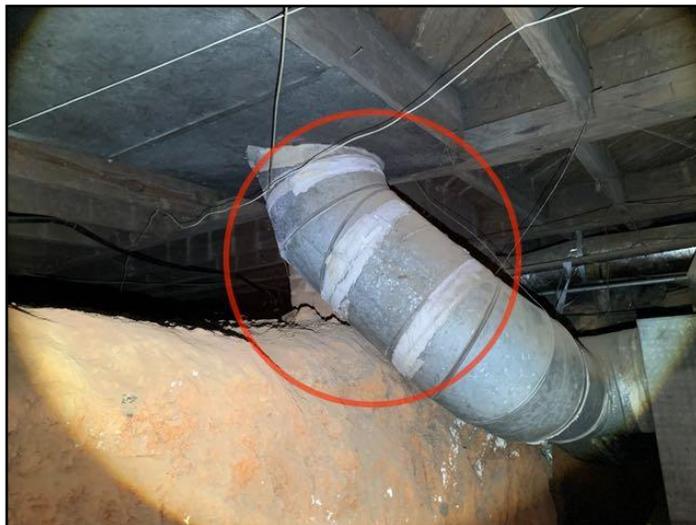
142. HVAC tape wrap

79. Condition: • Evidence of Rodents
