Your Inspection Report

SAMPLE THERMAL REPORT

Jose Gonzales, Certified Thermal Inspector

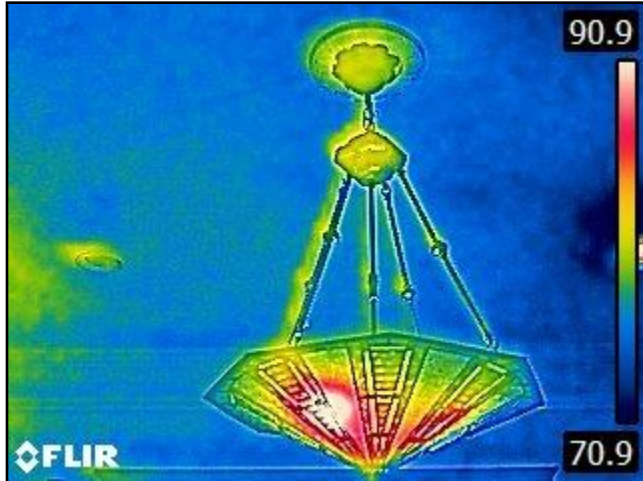
1. Scanned: No issues.

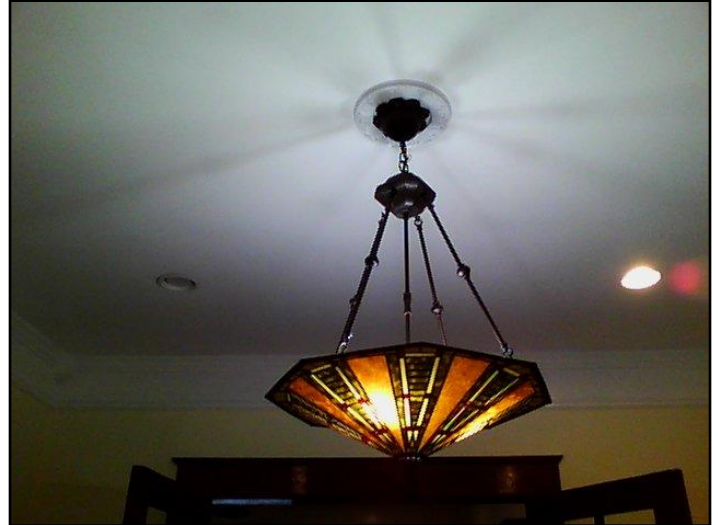
2. Scanned: No issues.

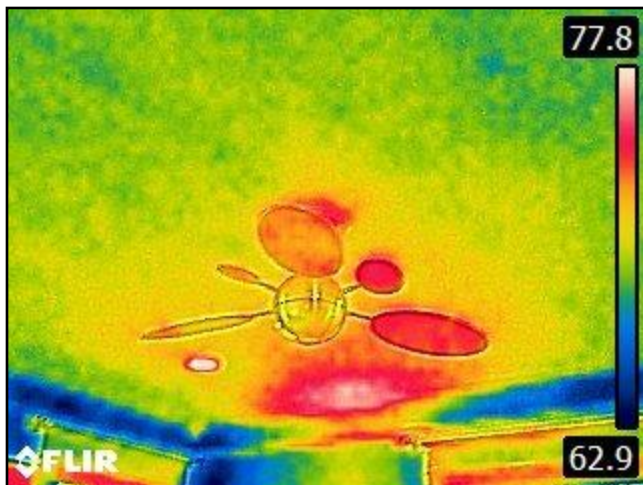
3. Scanned: No issues.

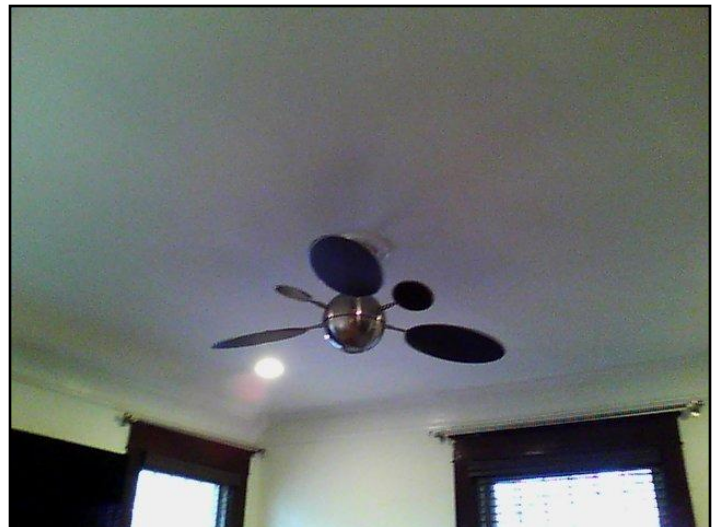
4. Scanned: No issues.

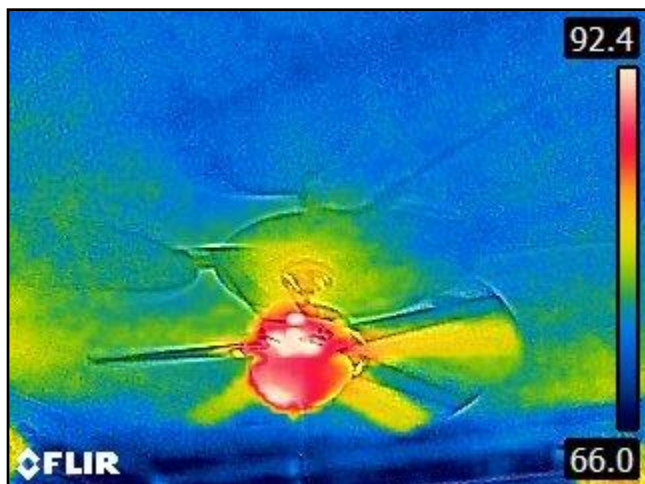
5. Scanned: No issues.

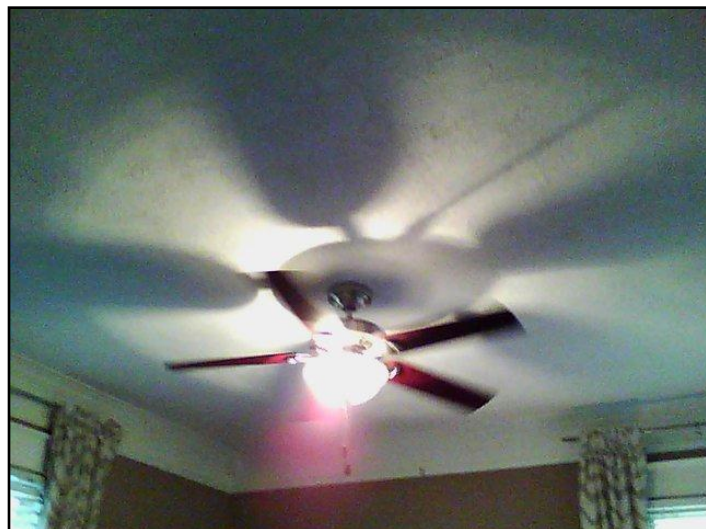
6. Scanned: No issues.

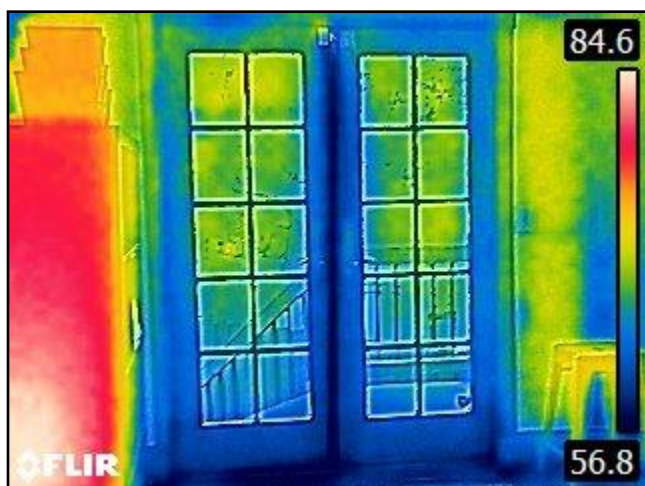
7. Scanned: No issues.

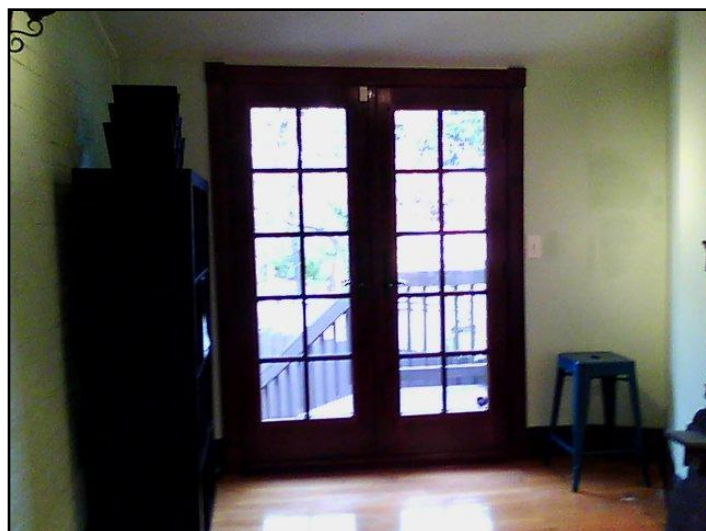
8. Scanned: No issues.

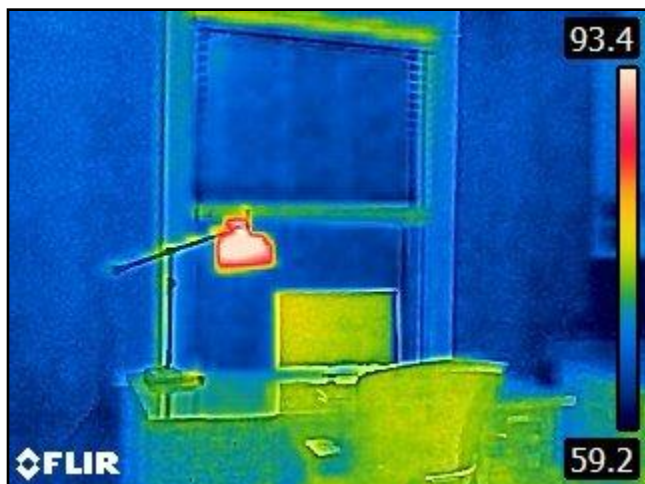
9. Scanned: No issues.

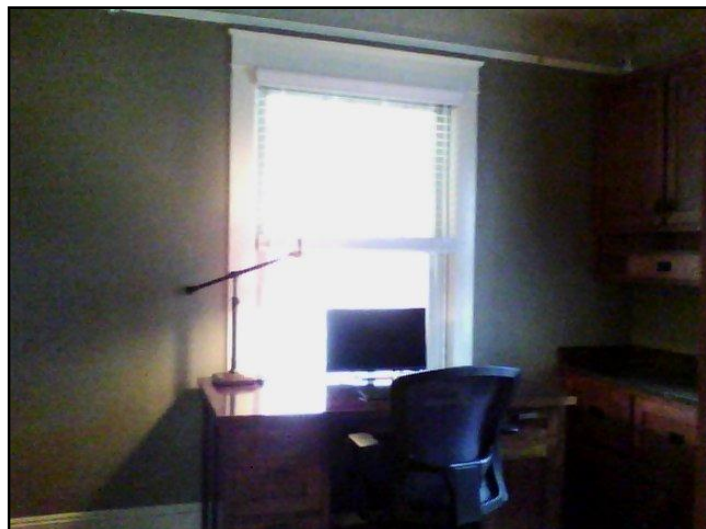
10. Scanned: No issues.

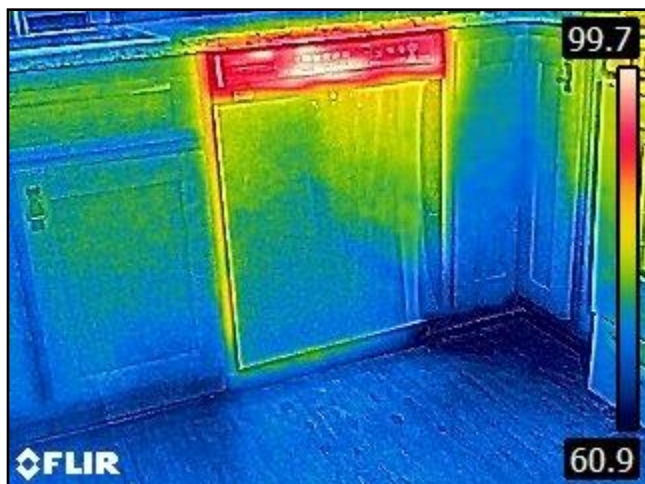
11. Scanned: No issues.

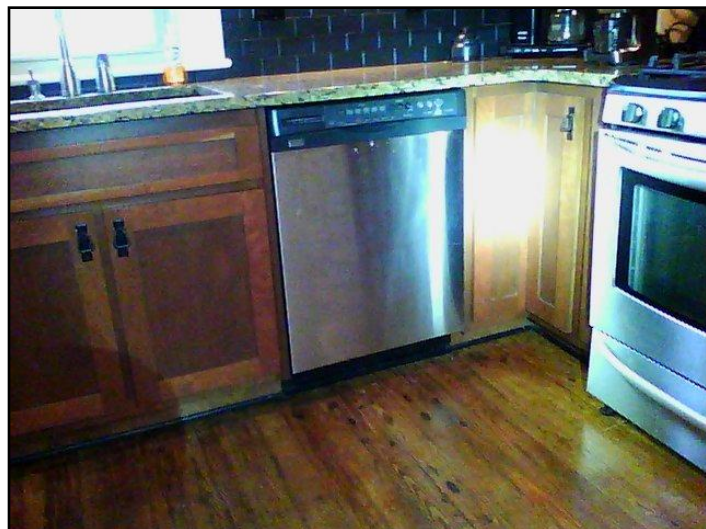
12. Scanned: No issues.

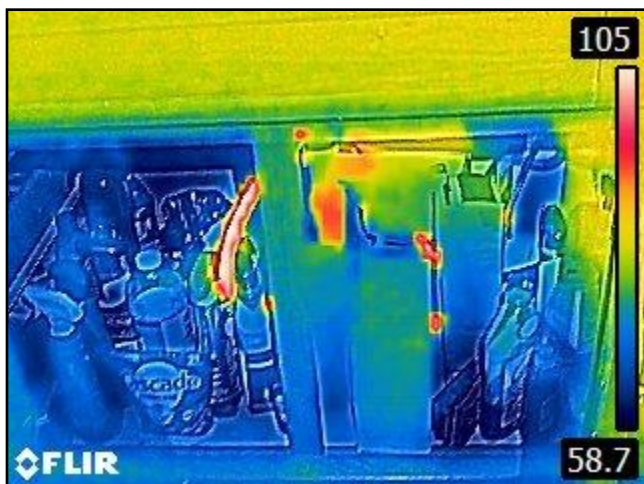
13. Scanned: No issues.

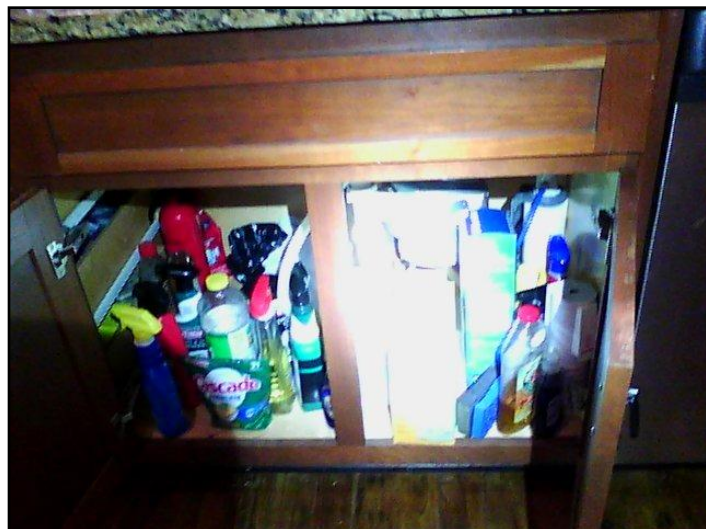
14. Scanned: No issues.

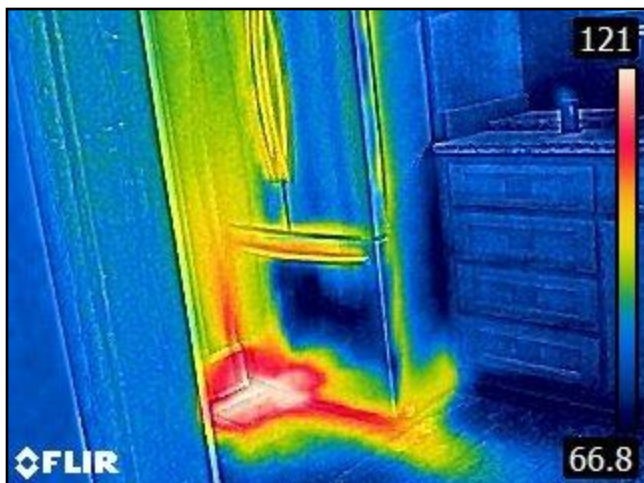
15. Scanned: No issues.

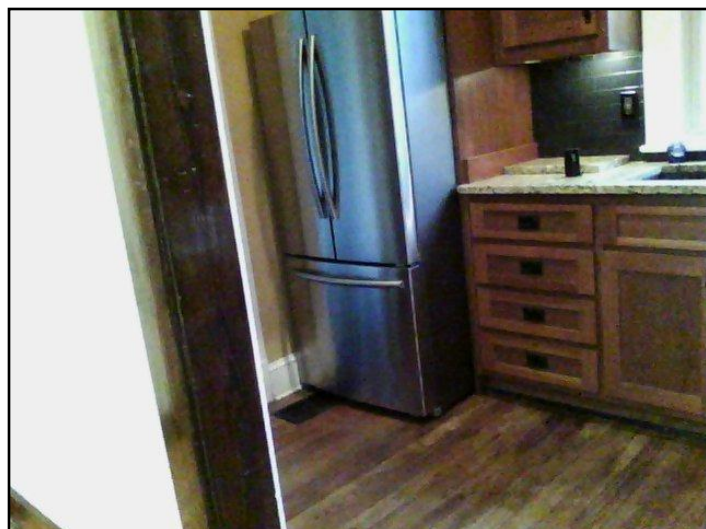
16. Scanned: No issues.

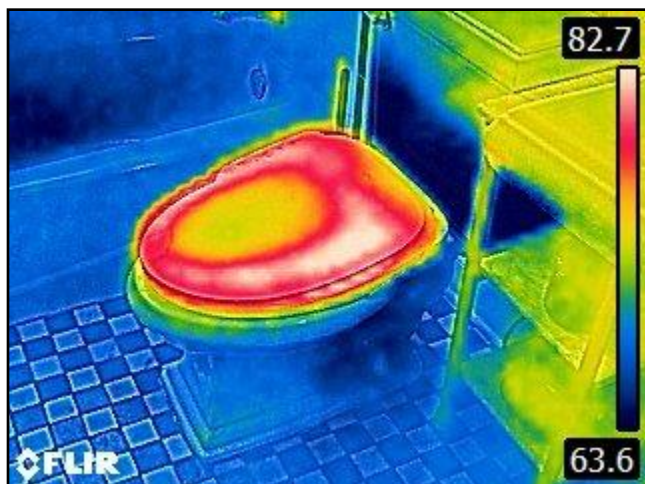
17. Scanned: No issues.

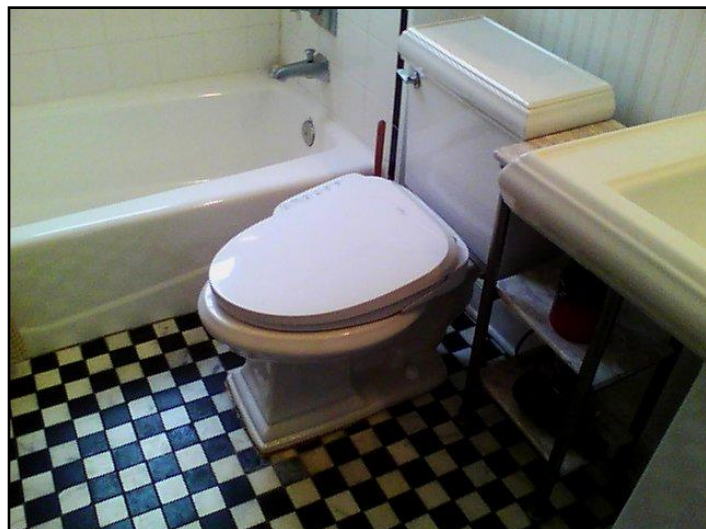
18. Scanned: No issues.

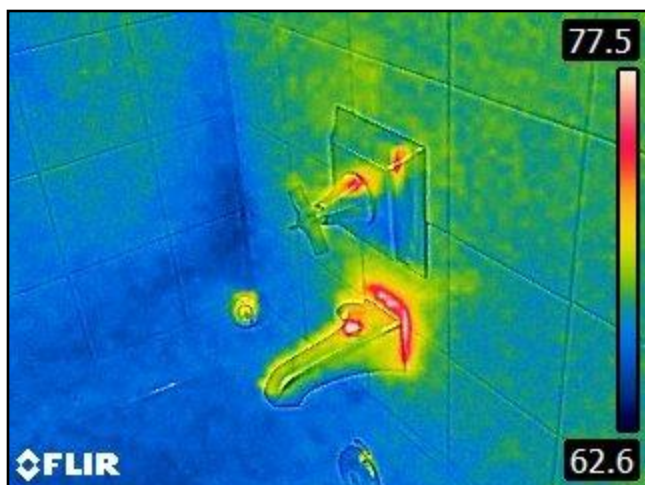
19. Scanned: No issues.

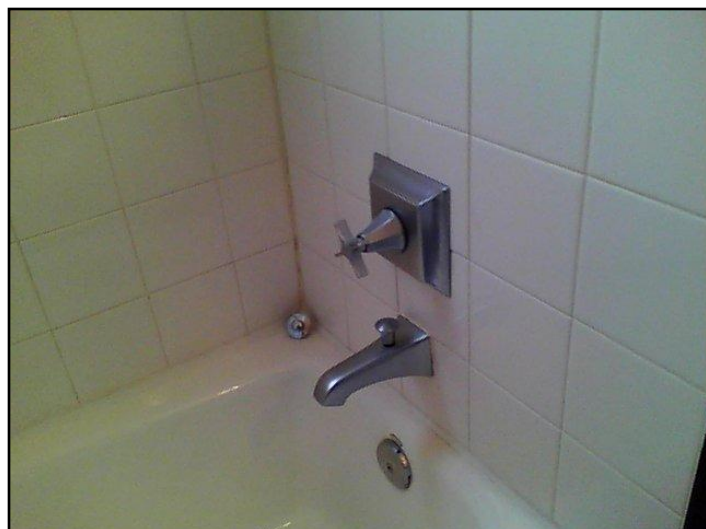
20. Scanned: No issues.

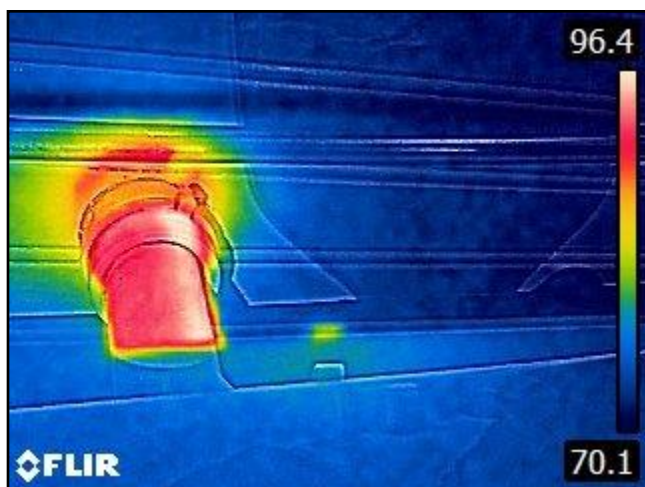
21. Scanned: No issues.

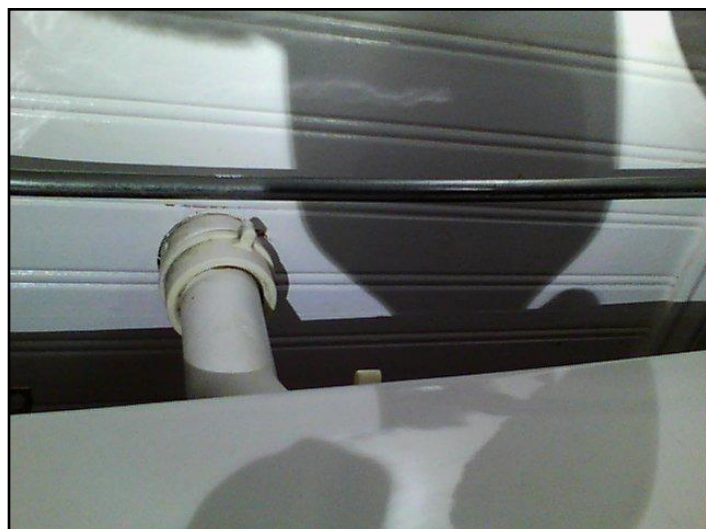
22. Scanned: No issues.

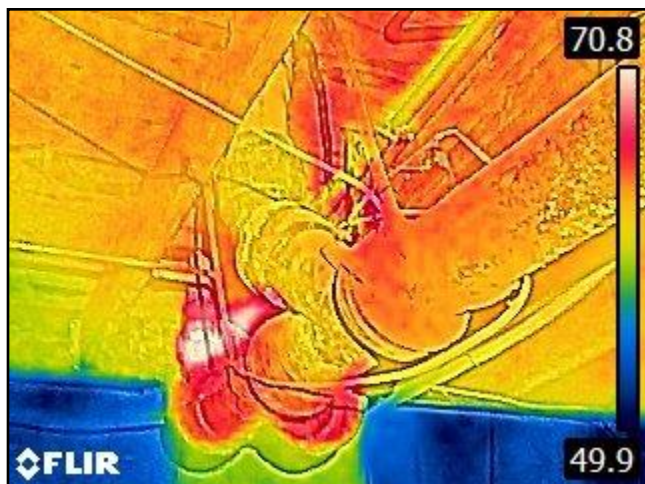
23. Scanned: No issues.

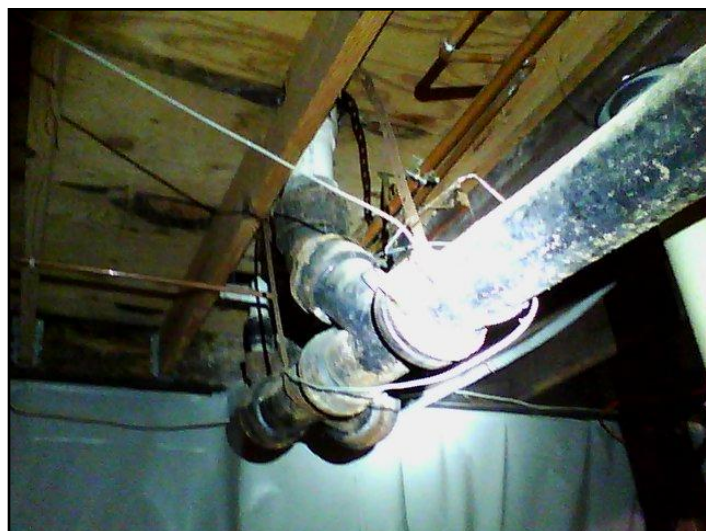
24. Scanned: No issues.

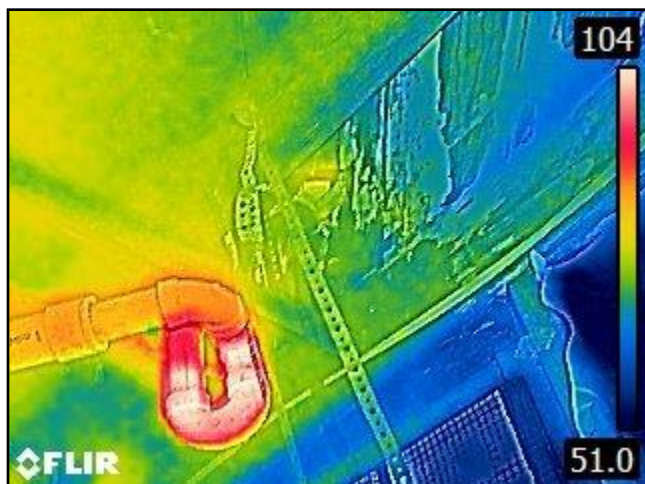
25. Scanned: No issues.

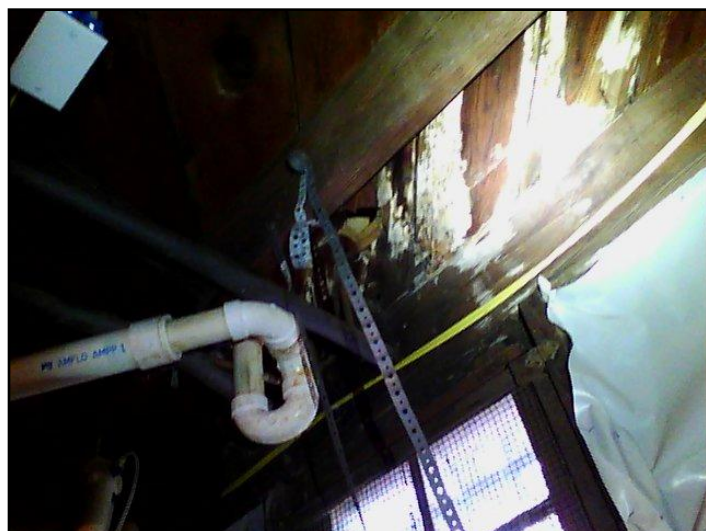
26. Scanned: No issues.

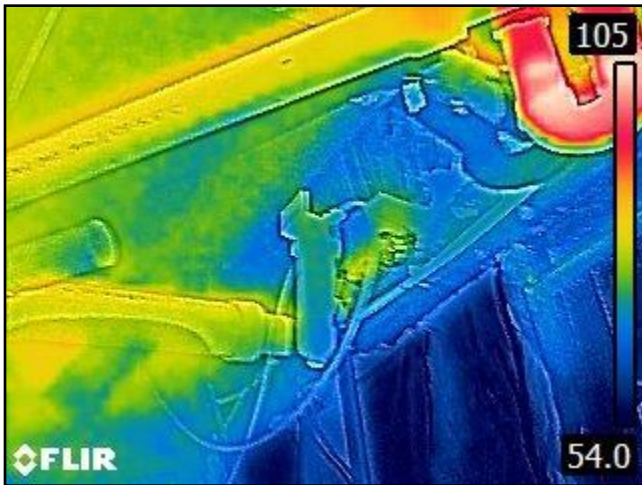
27. Scanned: No issues.

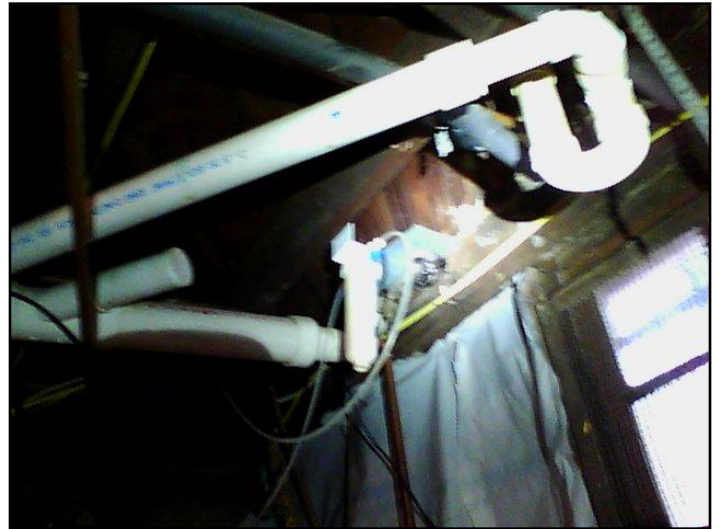
28. Scanned: No issues.

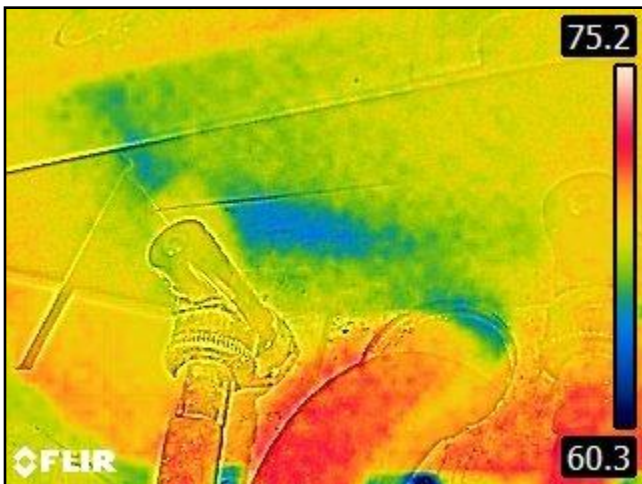
29. Scanned: No issues.

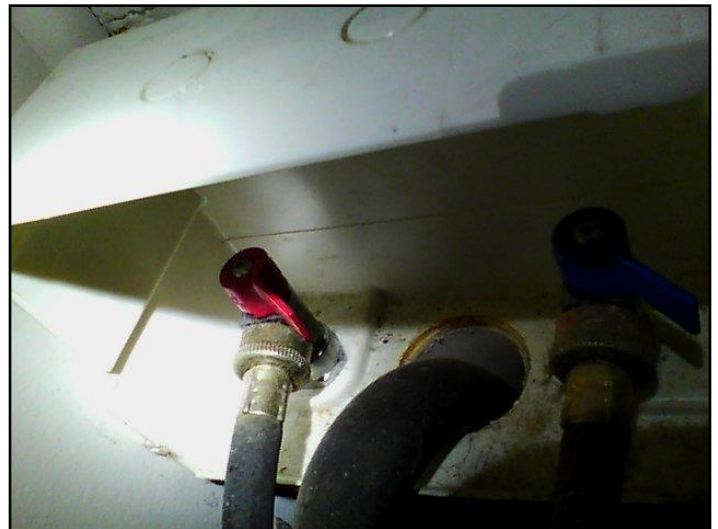
30. Scanned: No issues.
