Your Inspection Report

650 Arnold Court
Marietta, GA 30063

INSPECTION DATE:
Wednesday, April 21, 2021

RE: Report No. 38925, v.2
650 Arnold Court
Marietta, GA
30063

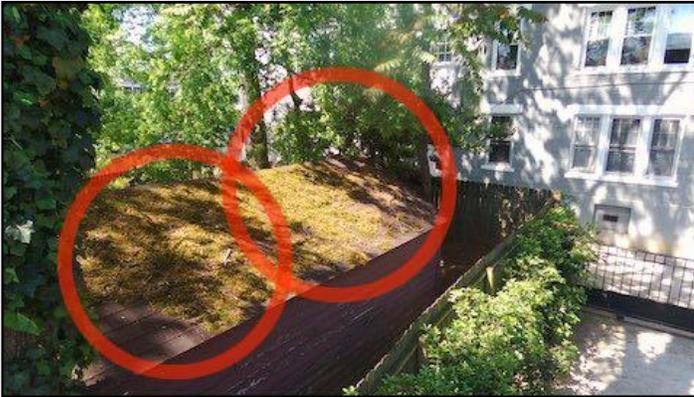
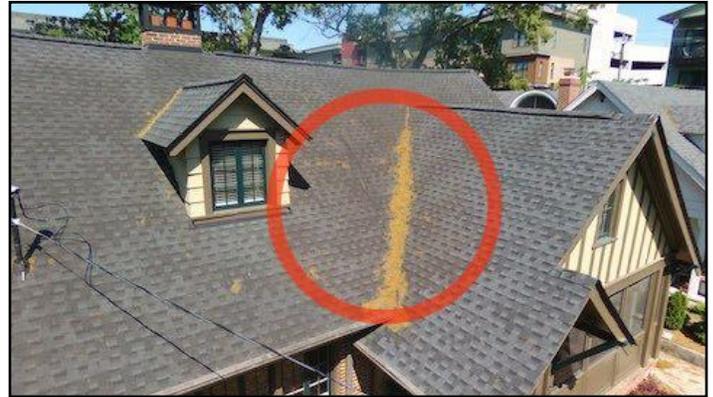
1. **Condition:** • Leaves/Debris

Task: Clean

Time: As Soon As Possible

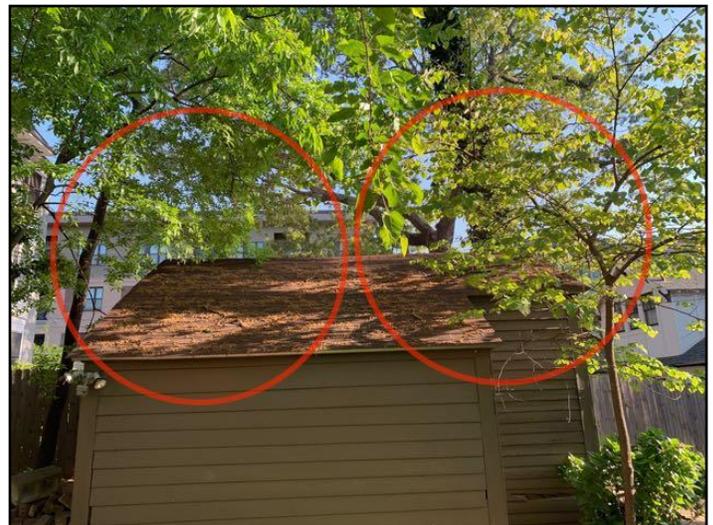
2. **Condition:** • Tree branches touching/too close to roof

Time: As Soon As Possible

Cost: Regular maintenance item

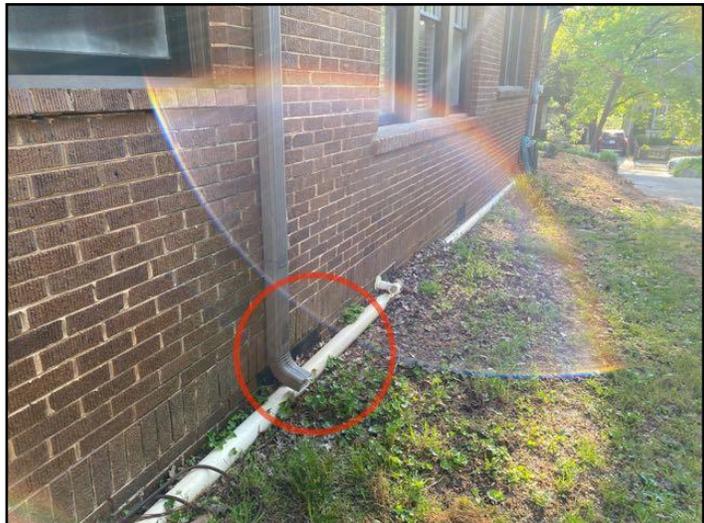
12. Left side

3. Condition: • Discharges Too Close to the Building

Time: Immediate

Cost: Minor

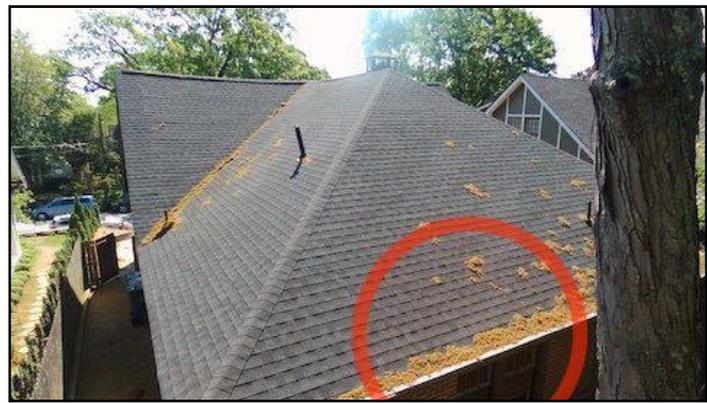
4. Condition: • Clogged

13. Clogged

Time: As Soon As Possible

Cost: Regular maintenance item

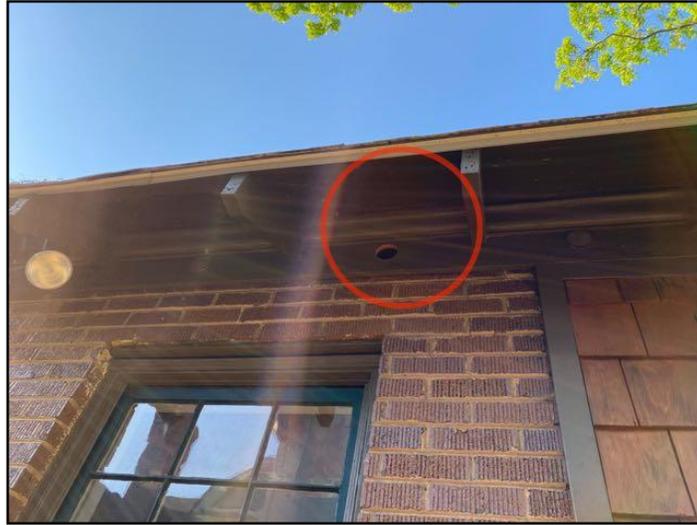
14. Right side

5. Condition: • Gaps/entry points around perimeter

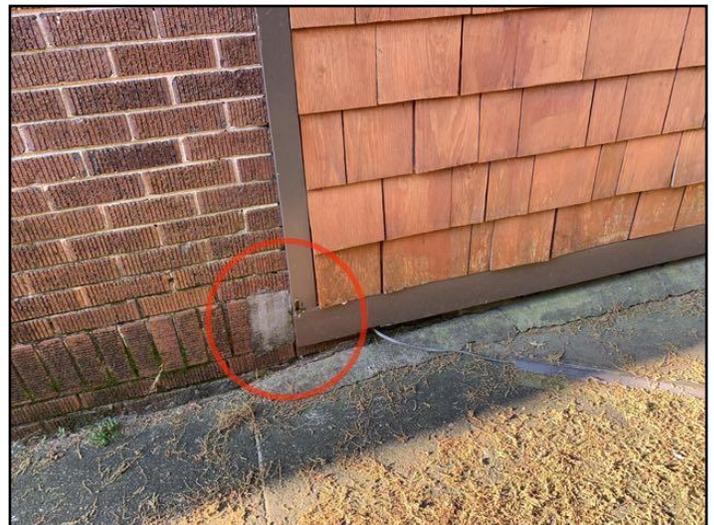
WALLS \ Siding and trim

Time: Immediate

Cost: \$150 - \$300 per location

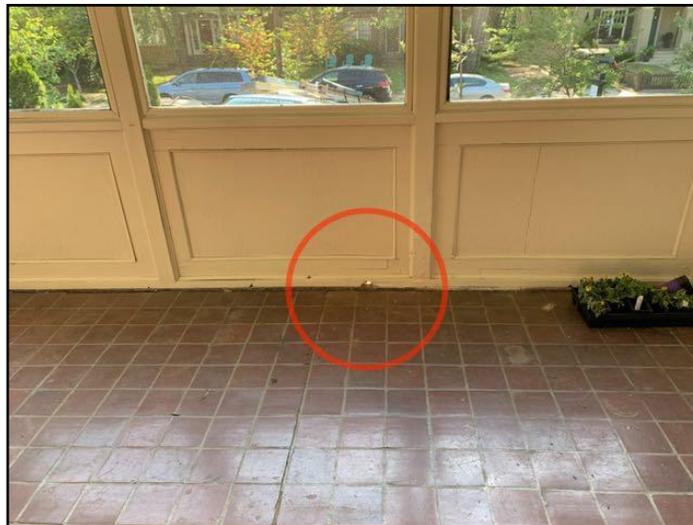
19. Front porch

7. Condition: • Gaps at through wall penetrations

Time: As Soon As Possible

Cost: Regular maintenance item

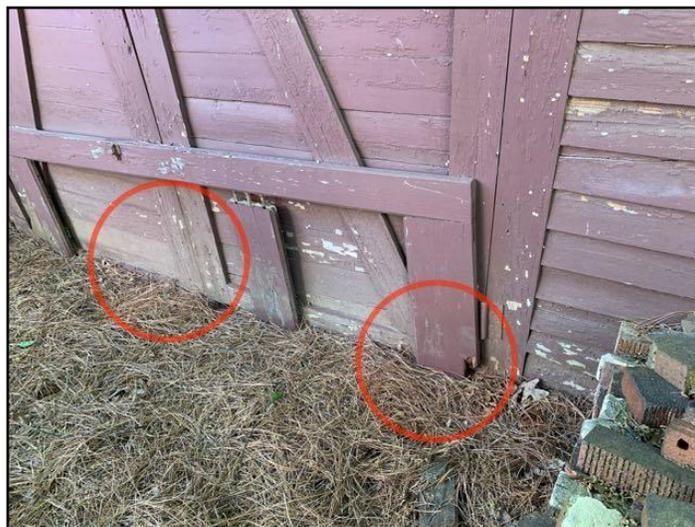
20. Rear garage

8. Condition: • Too close to grade

Cost: Minor

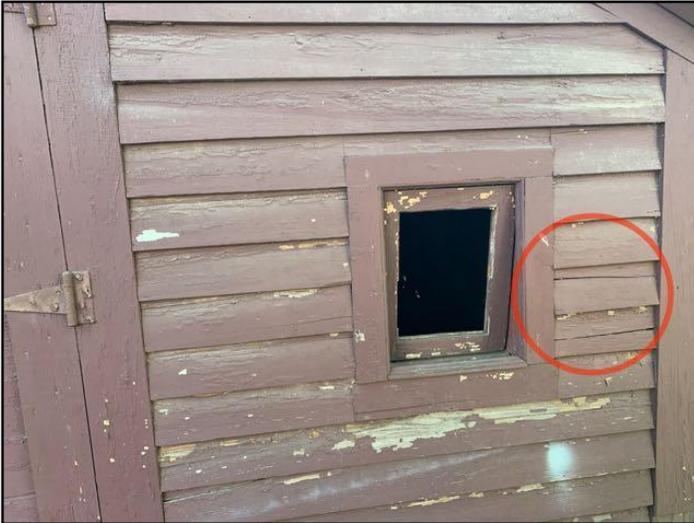
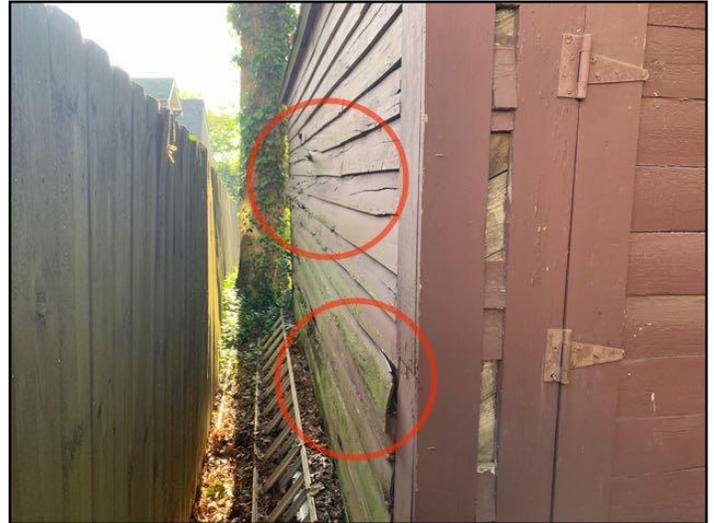
9. Condition: • Cracked/Split/Broken boards

Time: Immediate

Cost: Minor for board replacement, However, there should be a consideration for paint as matching existing paint is usually difficult this may result in added repair costs

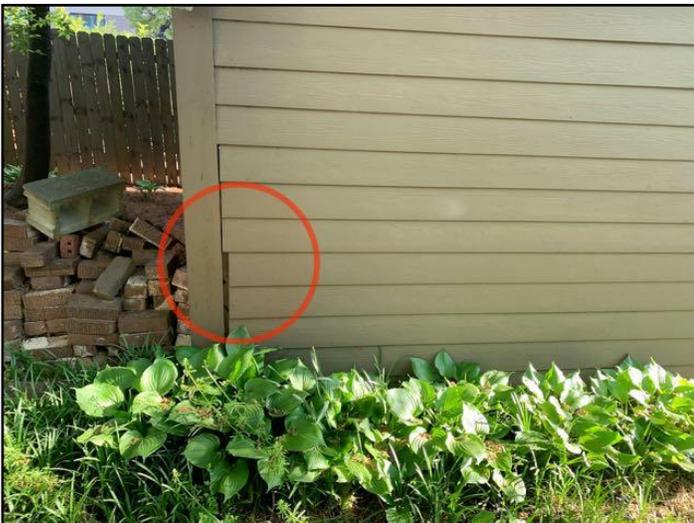
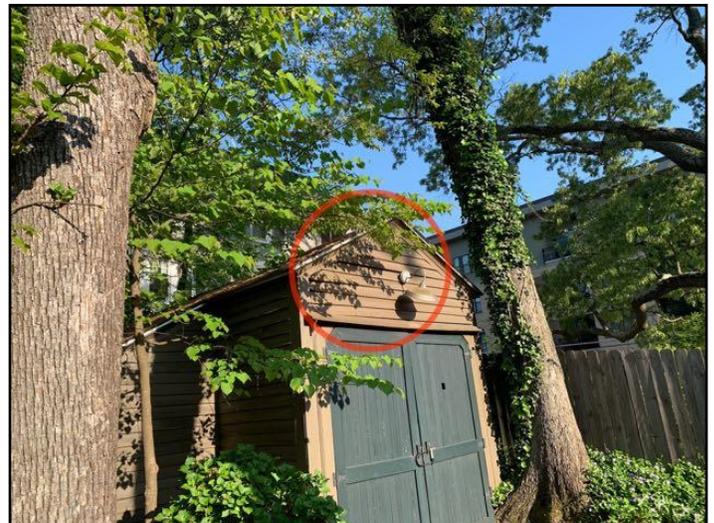
10. Condition: • Loose or missing pieces

24. Loose or missing pieces

Time: Immediate

Cost: Minor

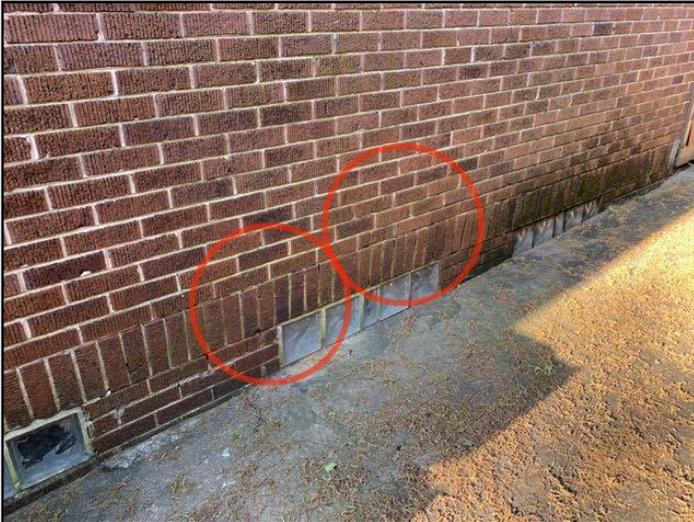
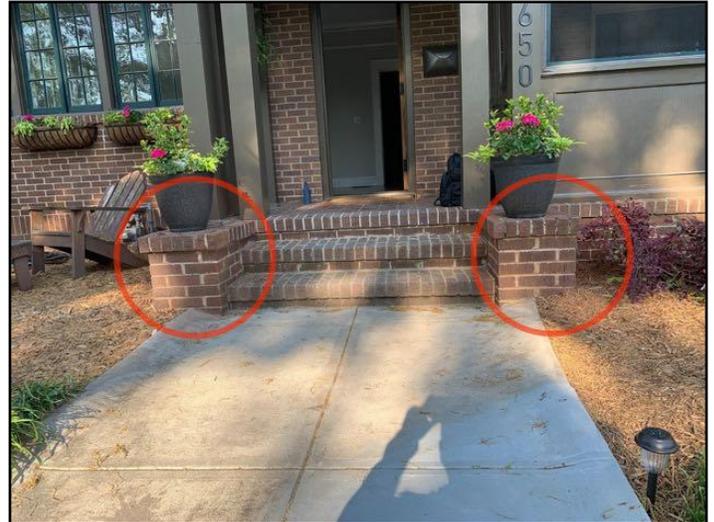
11. Condition: • Mortar deterioration

Time: As Soon As Possible

Cost: Regular maintenance item

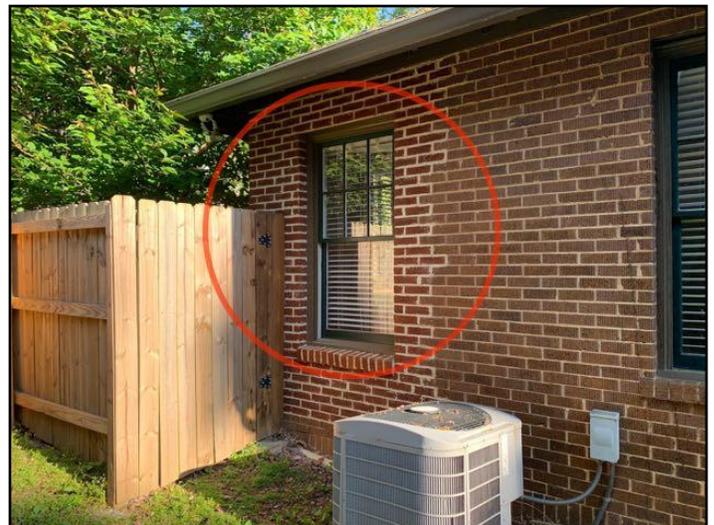
12. Condition: • Prior repairs to brick

Task: Request disclosure

Time: As Soon As Possible

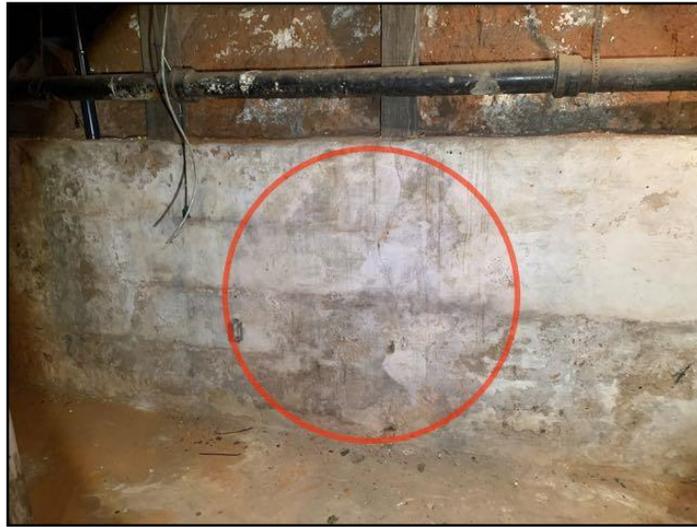
36. Rear

17. Condition: • Foundation has been under cut

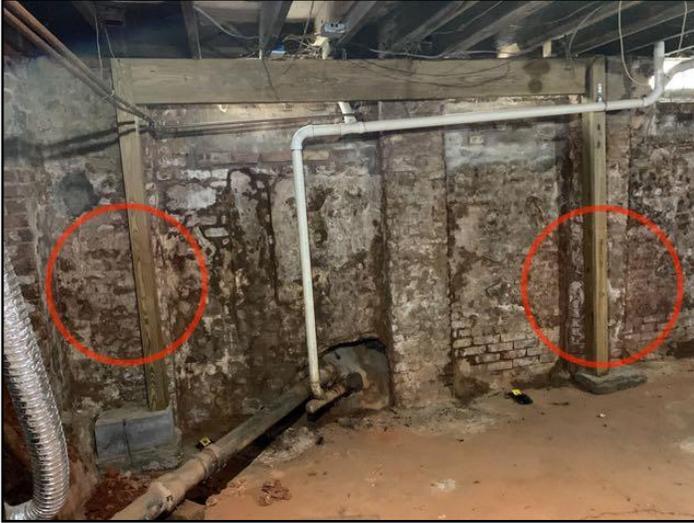
38. Right rear

18. Condition: • Temporary Supports - NO Issues

Although there are no issues with the temporary or supplemental supports installed in the crawlspace, this is usually done in response to some type of movement or settling and as a temporary corrective measure. Although there were no issues noted that were a concern at the time of inspection, it is recommended that a qualified contractor install more permanent supports that are properly secured at the top and bottom.

Task: Repair As Needed

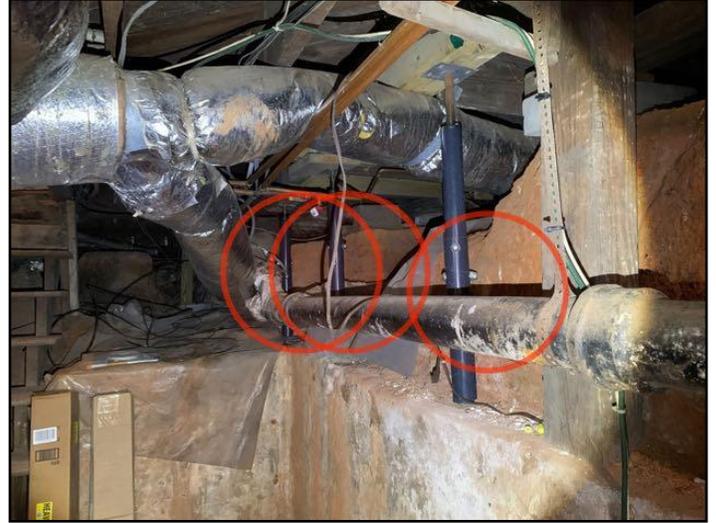
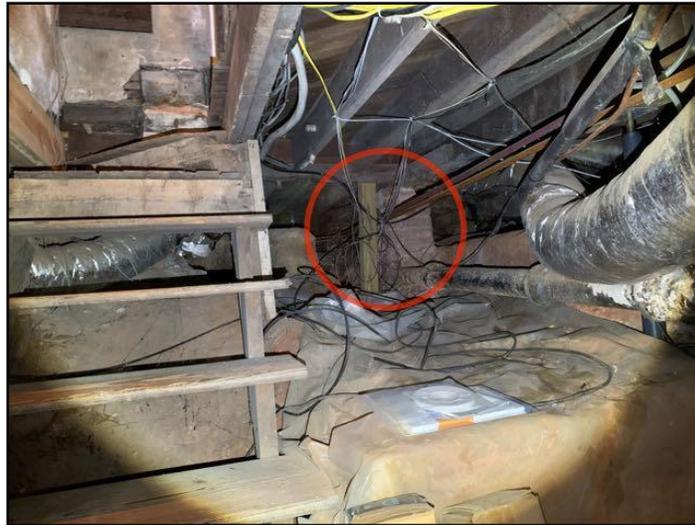
19. Condition: • Rust/Compromised/Damaged

Task: Replace
Time: As Soon As Possible
Cost: \$200 - \$400 Each

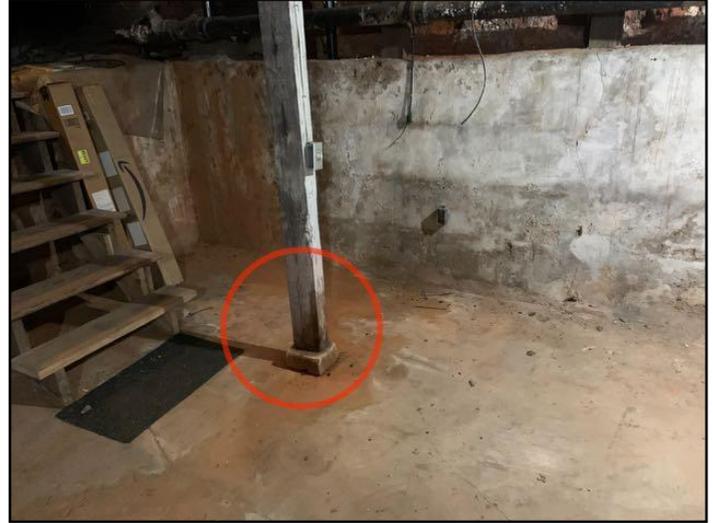
42. Left rear

20. Condition: • Column bowing

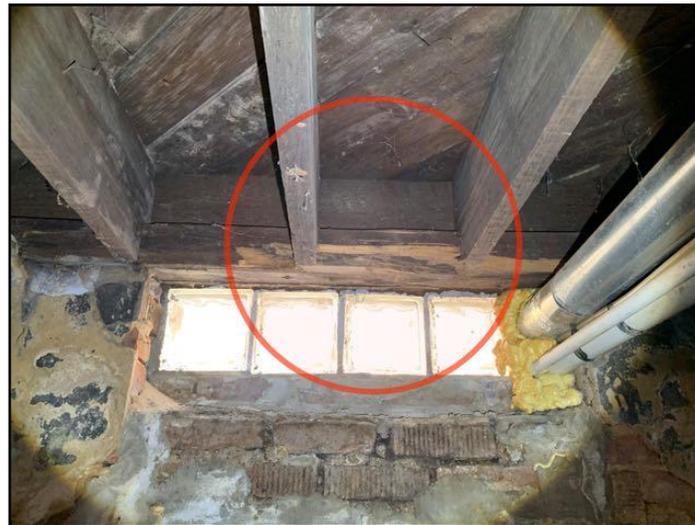
48. Right side

22. Condition: • [Insect damage](#)

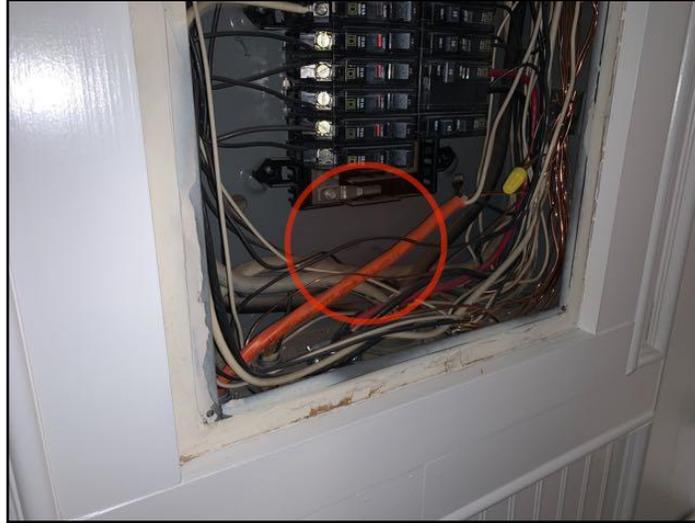
26. Condition: • Excessive sheathing length inside of panel

52. Excessive sheathing length

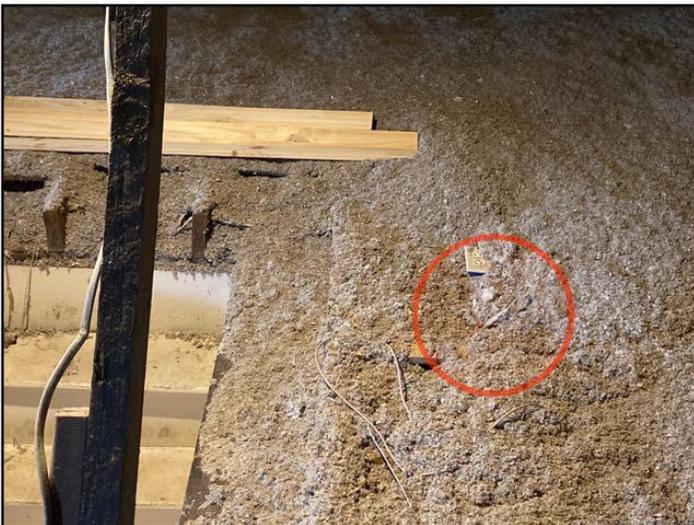
27. Condition: • Abandoned Wiring

Wire appears to be serving no purpose and should be removed to eliminate any possible safety hazard.

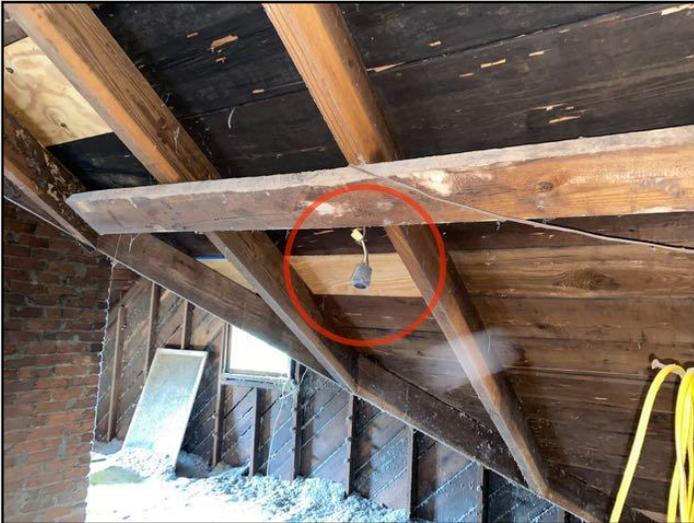
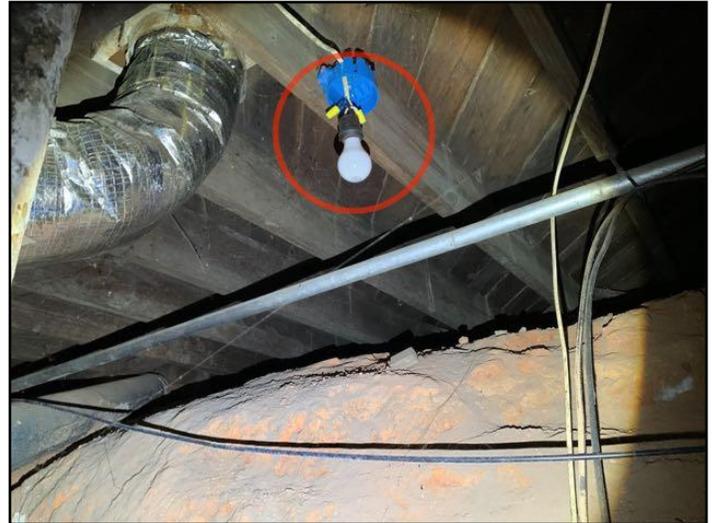
28. Condition: • Open splices
Installation of Junction Box with cover

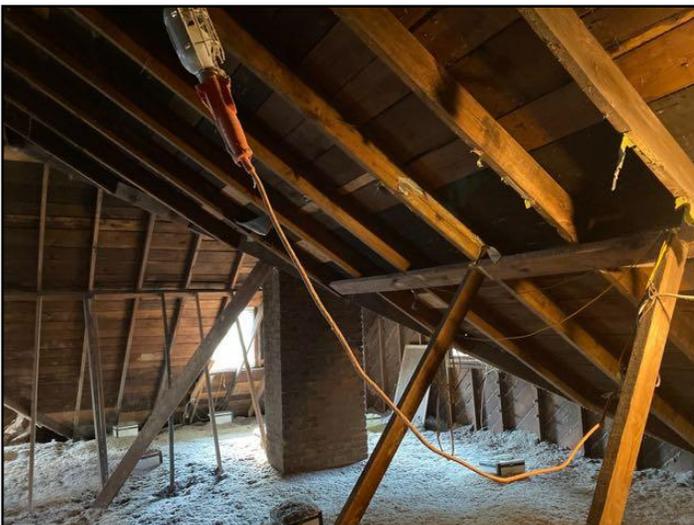
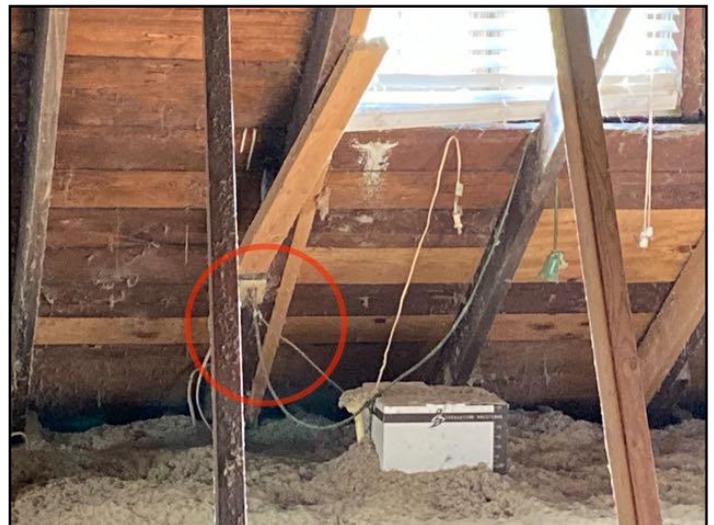
29. Condition: • Extension cord used for permanent wiring

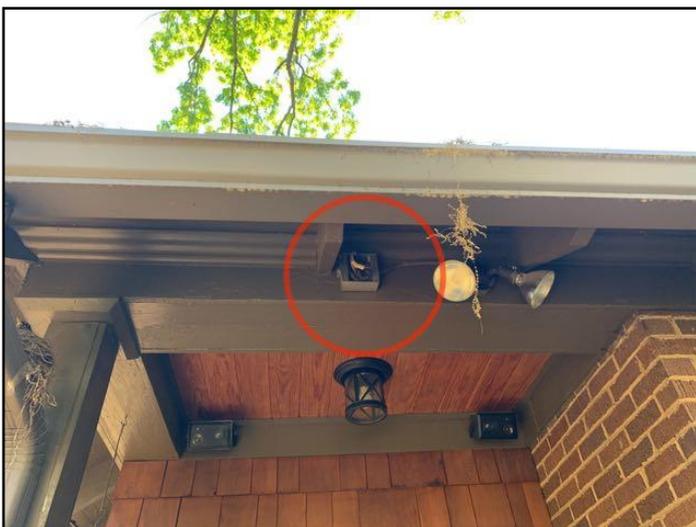
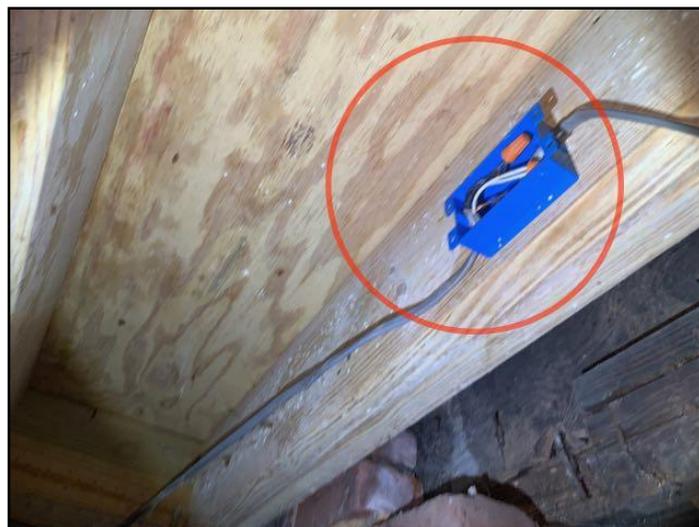
31. Condition: • Cover loose or missing

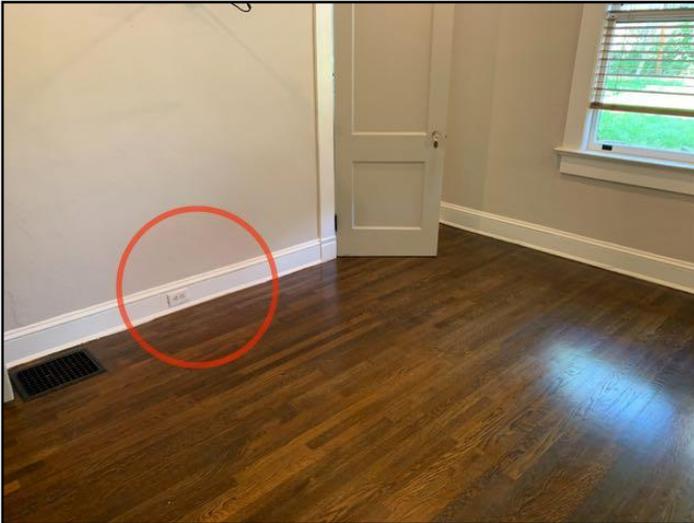
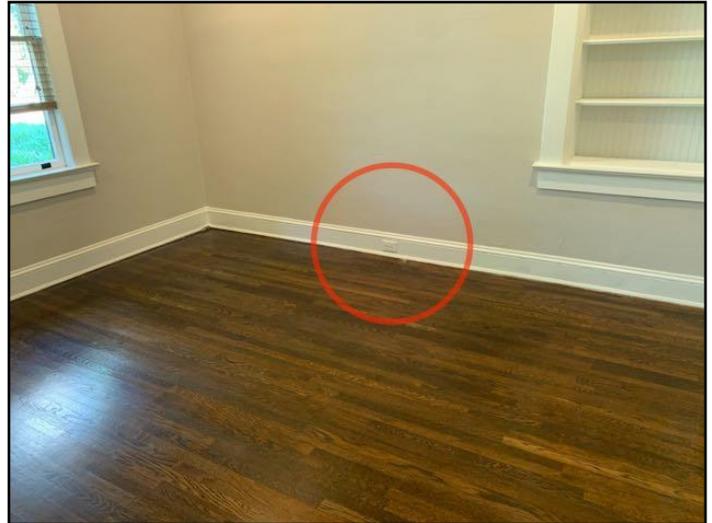
32. Condition: • Ungrounded

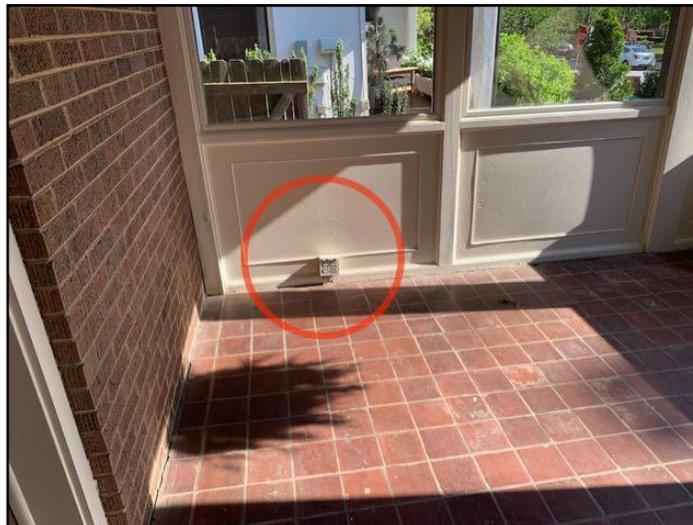
65. Front porch

34. Condition: • No GFCI/GFI (Ground Fault Circuit Interrupter)

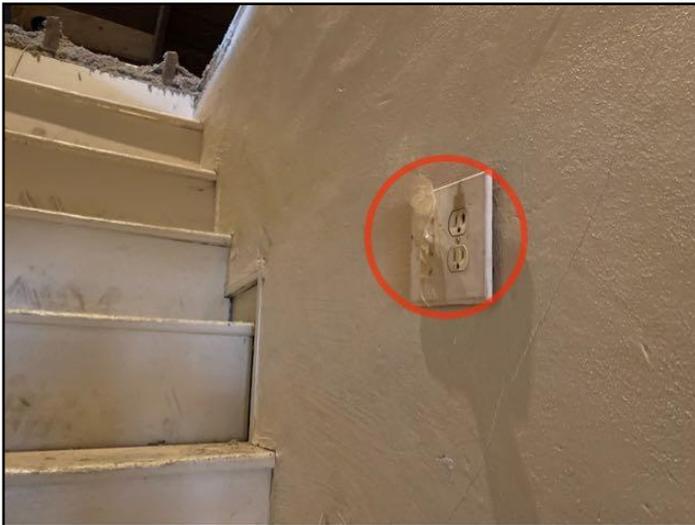
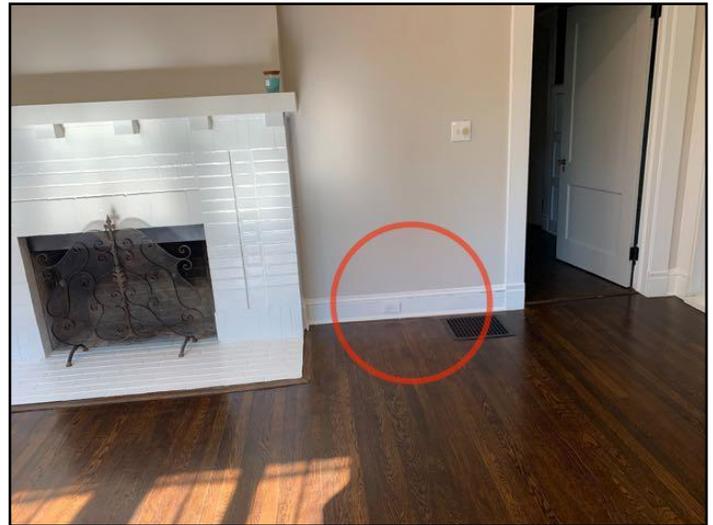
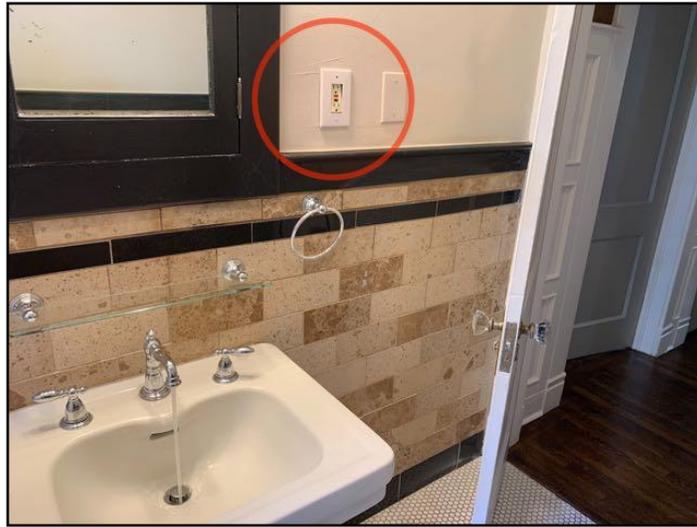
36. Condition: • Loose Receptacles (Outlets) noted

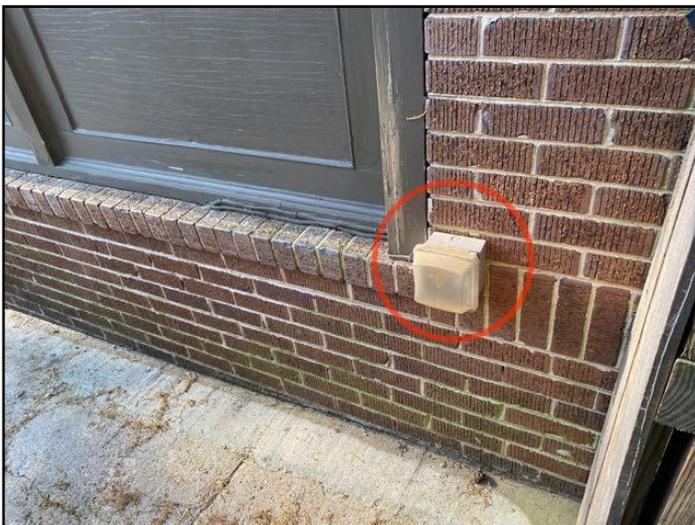
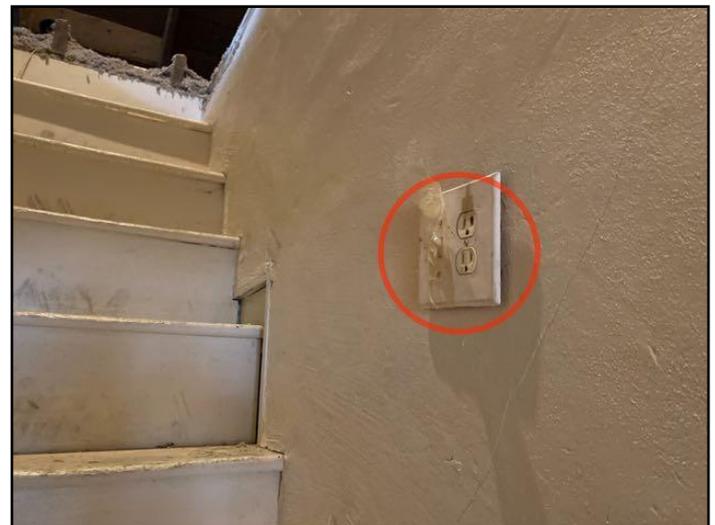
37. Condition: • Inoperative

Task: Replace

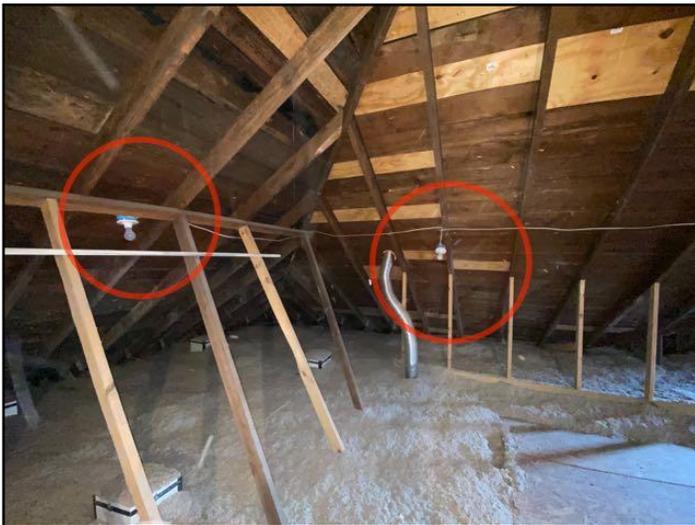
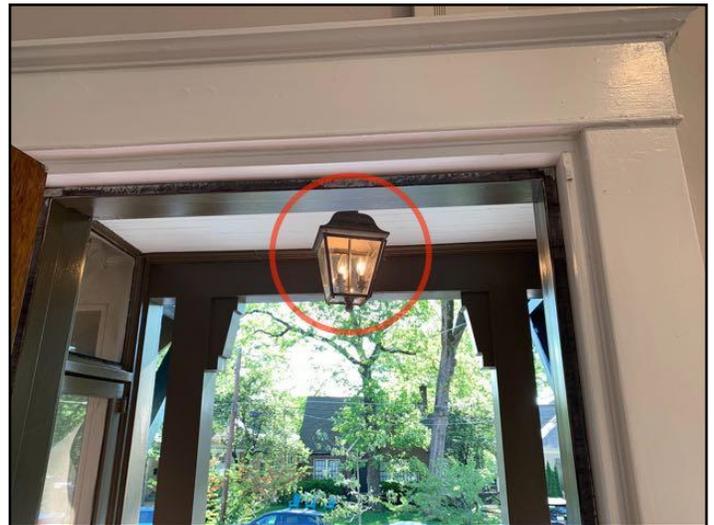
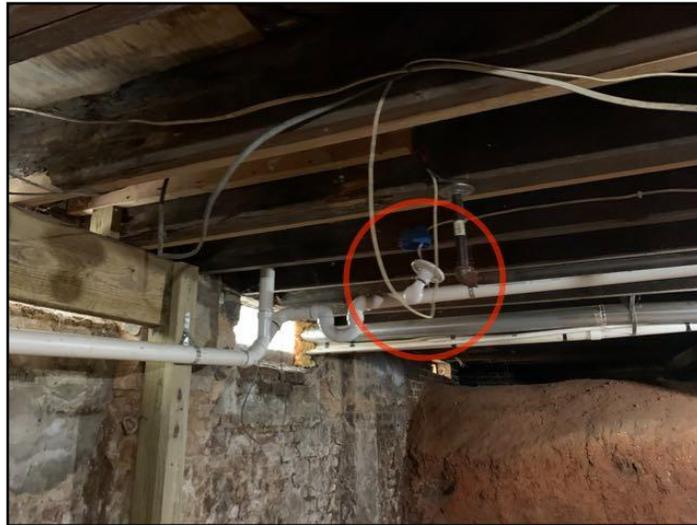
39. Condition: • Inoperative

This is most likely blown bulbs and recommend confirming operation from the seller.

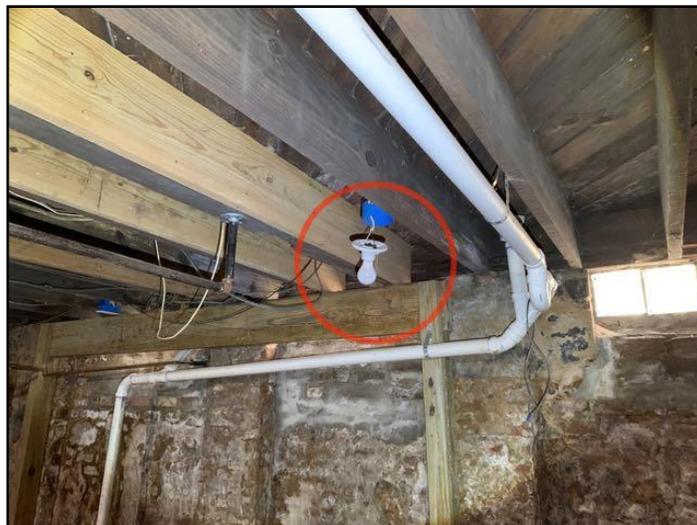
76. Right side basement

40. Condition: • Damaged Fixture

Task: Repair or replace

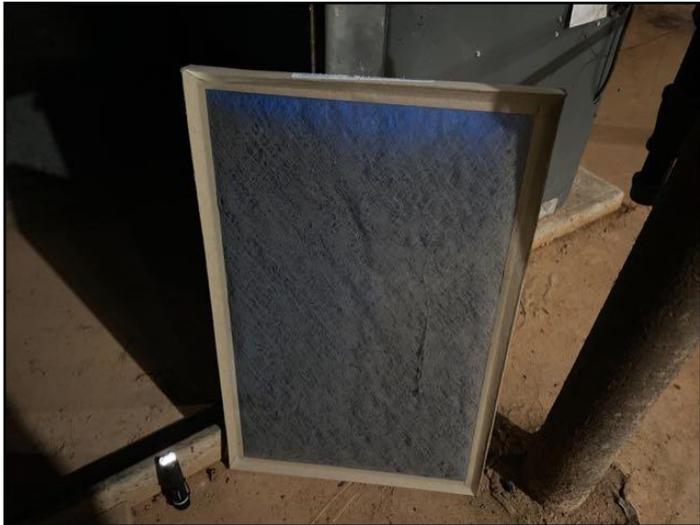
79. At furnace

42. Condition: • Dirty

Given the dirty operating condition of the system, servicing is recommended

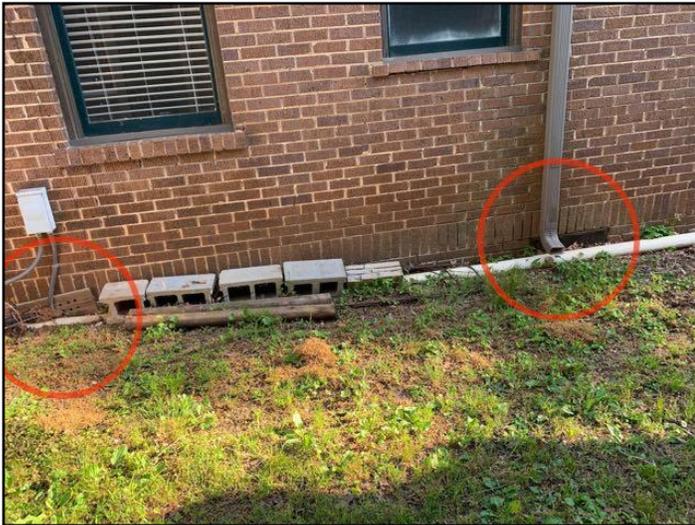
90. Left side

50. Condition: • Vent at or below grade
Location: Left side
Task: Correct
Time: Discretionary
Cost: Depends on the preferred remedy of repair

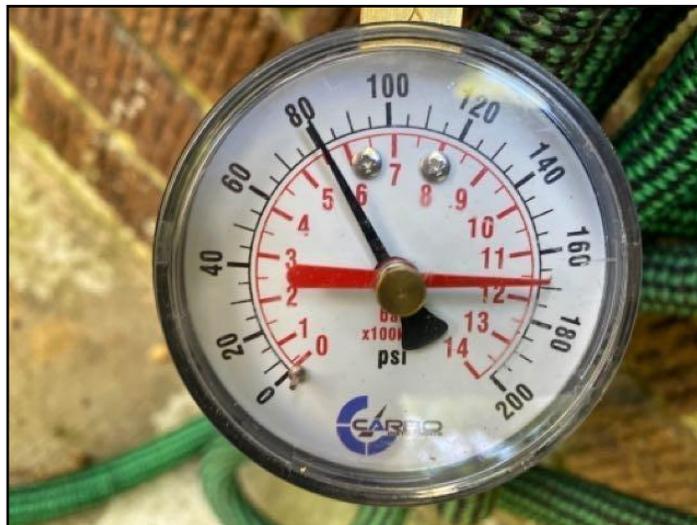
51. Condition: • Excessive Water Pressure

92. 80+ PSI

A qualified plumber will need to adjust/replace pressure regulator valve for pressure reading between 40 and 80 PSI.

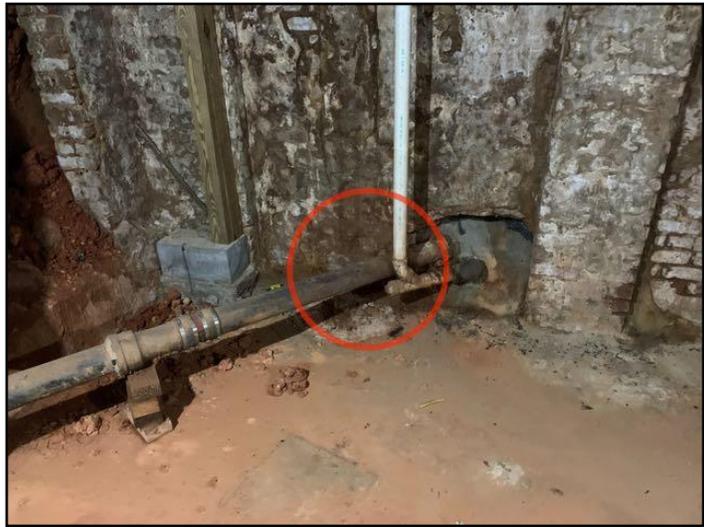
93. Right rear

52. Condition: • [Cast Iron drain line is present.](#)

Task: Prepare for Replacement

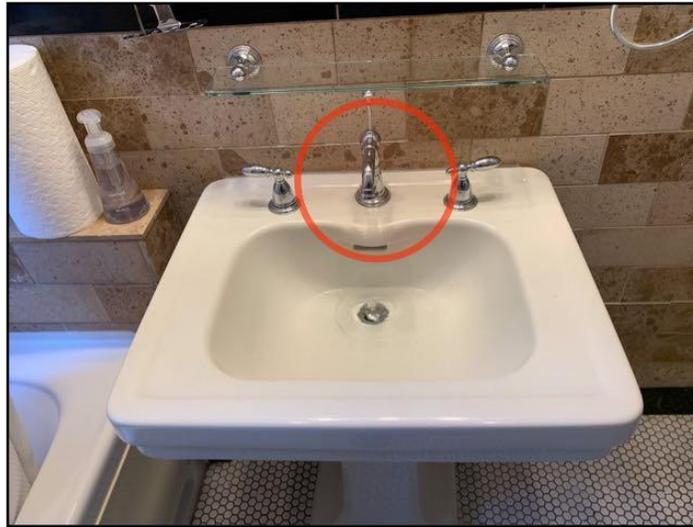
94. Hall bathroom

53. Condition: • Drip/Leak

Task: Repair

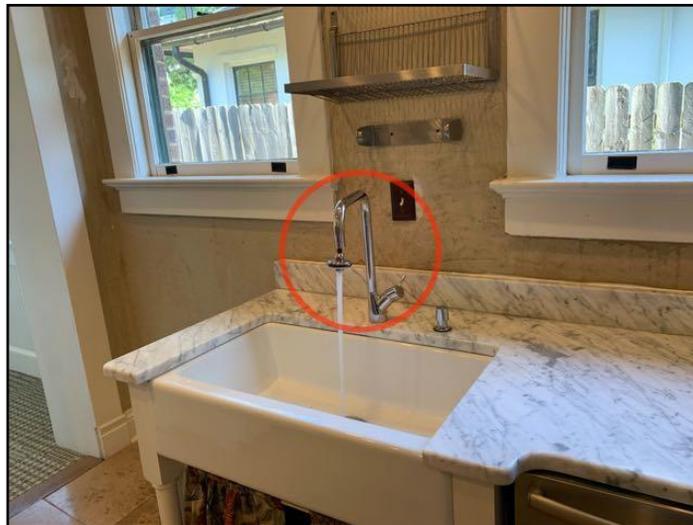
95. Kitchen

54. Condition: • Loose Faucet

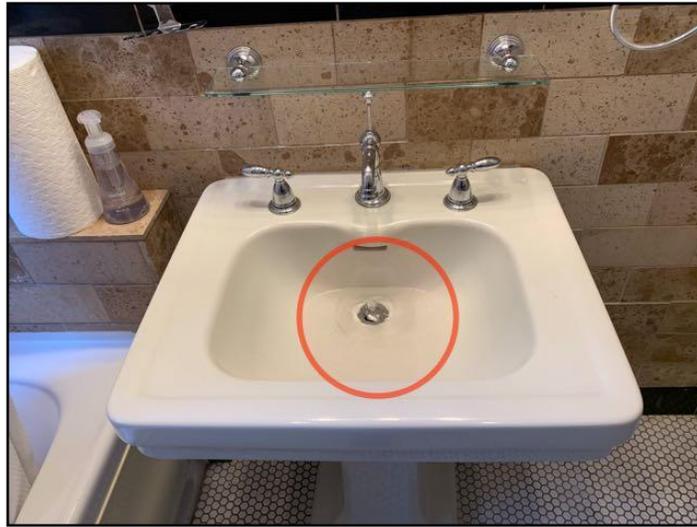
96. Hall bathroom

55. Condition: • Drain stop ineffective

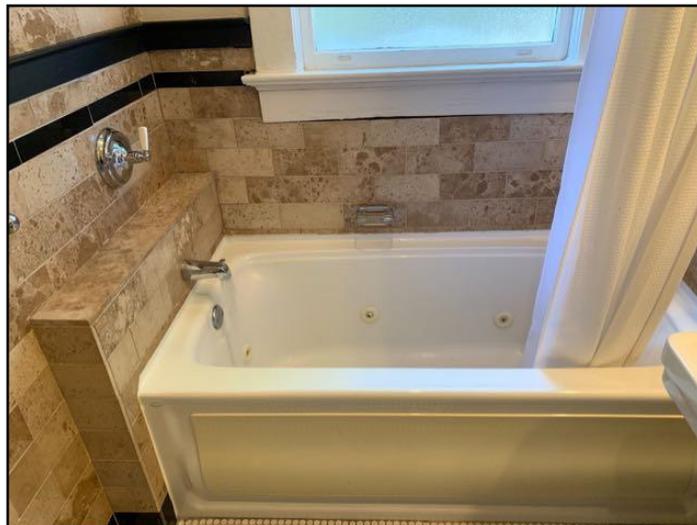
97. Hall bathroom

56. Condition: • Caulking/Grout missing and or deteriorated

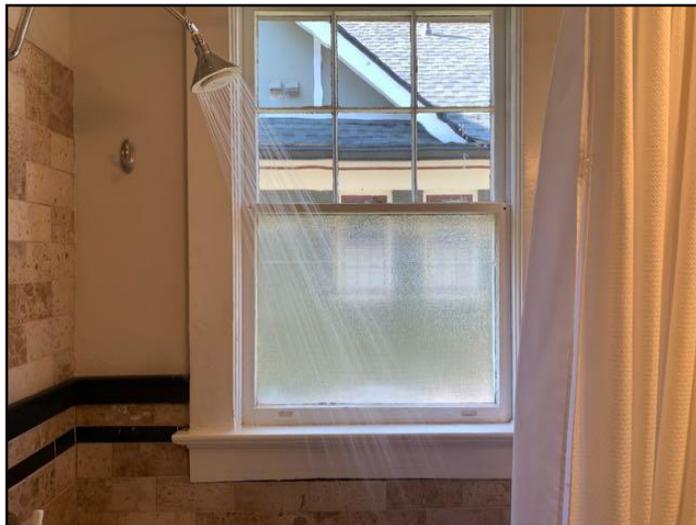
99. Hall bathroom

58. Condition: • Unprotected Window

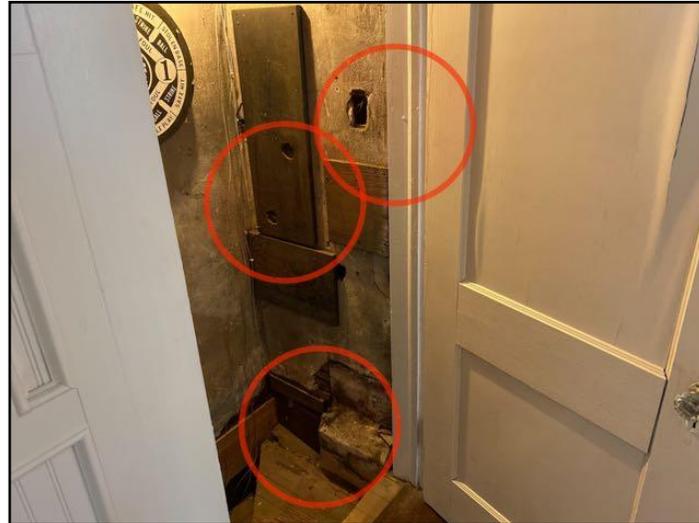
106. *Basement stairs*

59. Condition: • Missing Sections

Task: Replace

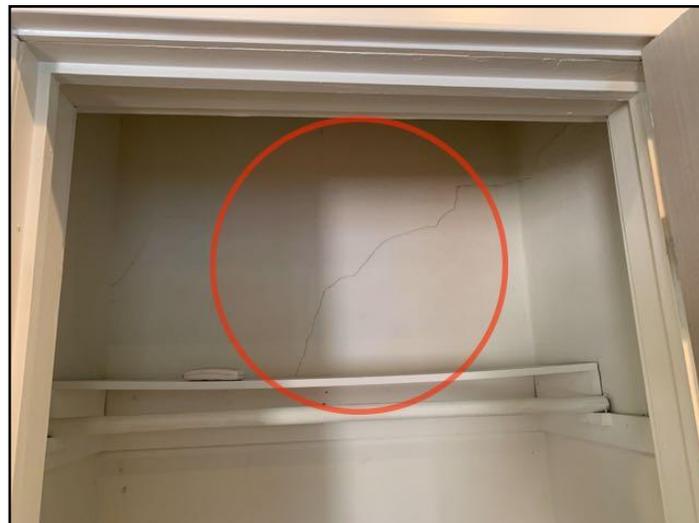
107. *Left rear bedroom closet*

60. Condition: • Cracks

This picture is representative - There is no evidence to indicate this is related to anything other than typical settling or age. Recommend monitoring to ensure cracks do not worsen.

Task: Be Advised, Monitor cracks to ensure they do not worsen

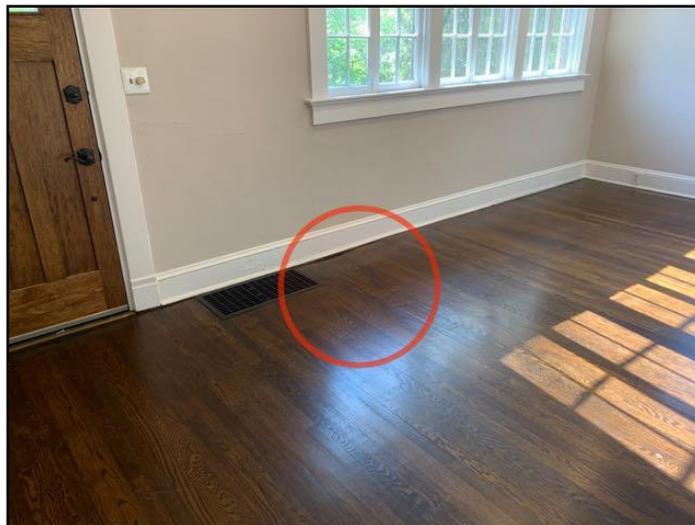
109. Living room

62. Condition: • [Sagging](#)

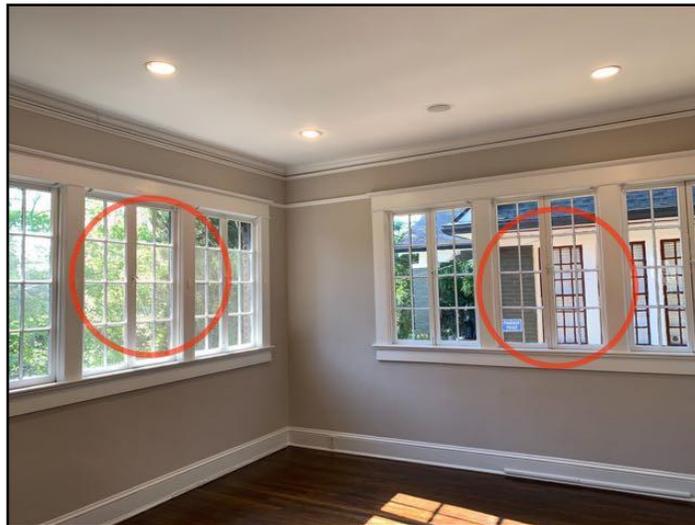
114. Living room

66. Condition: • Missing/Loose Hardware

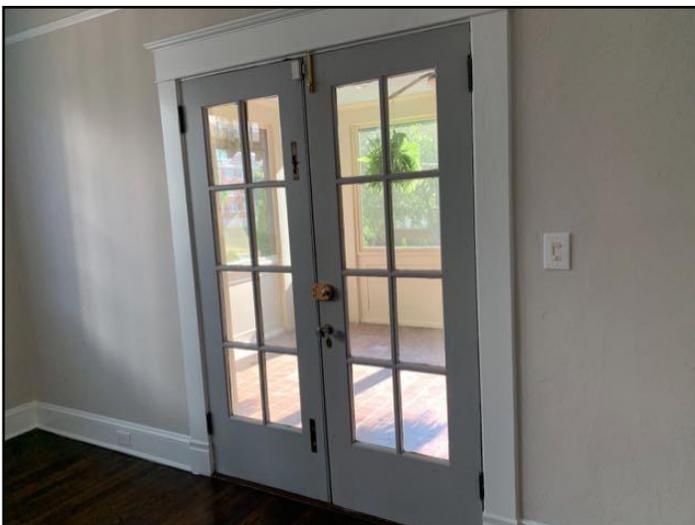
115. Exterior door to front porch

67. Condition: • Door Binds

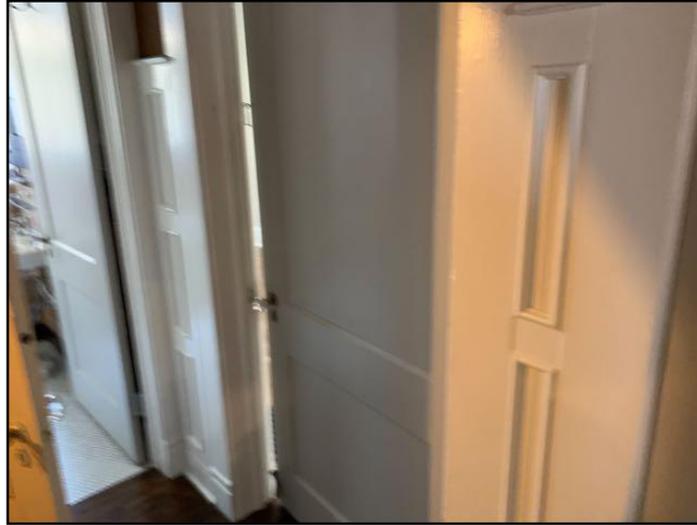
117. Left rear bedroom

68. Condition: • Does Not Latch Properly

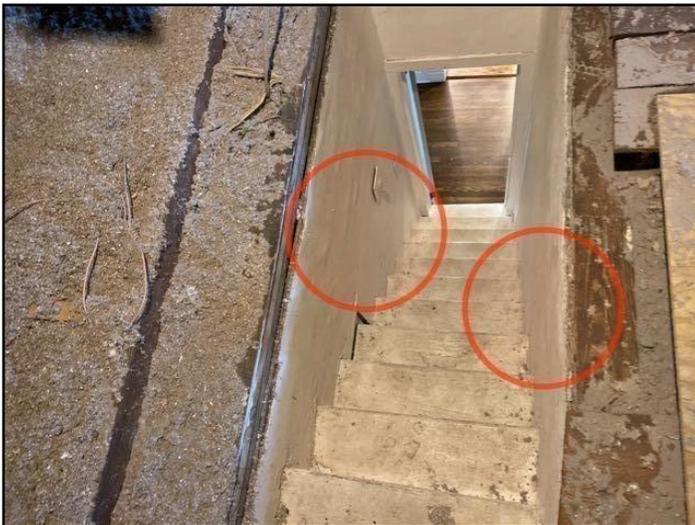
118. Attic stairs

69. Condition: • Handrail Missing

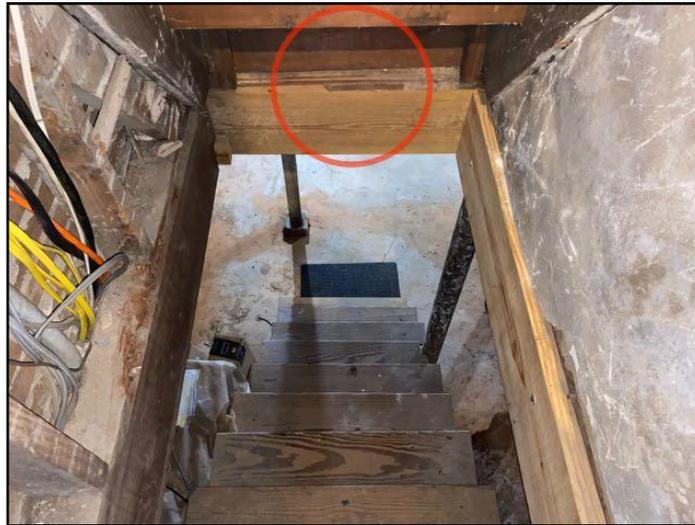
120. Basement stairs

70. Condition: • Headroom less than ideal
Location: Basement stairs
Task: Be Advised

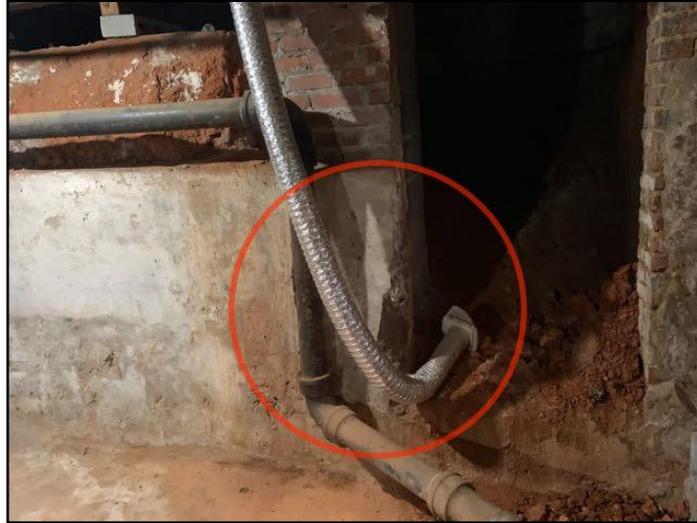
122. Right rear

72. Condition: • Does not discharge to exterior
