Your Inspection Report

650 Arnold Court
Marietta, GA 30063

INSPECTION DATE:
Wednesday, April 21, 2021

RE: Report No. 38925, v.2
650 Arnold Court
Marietta, GA
30063

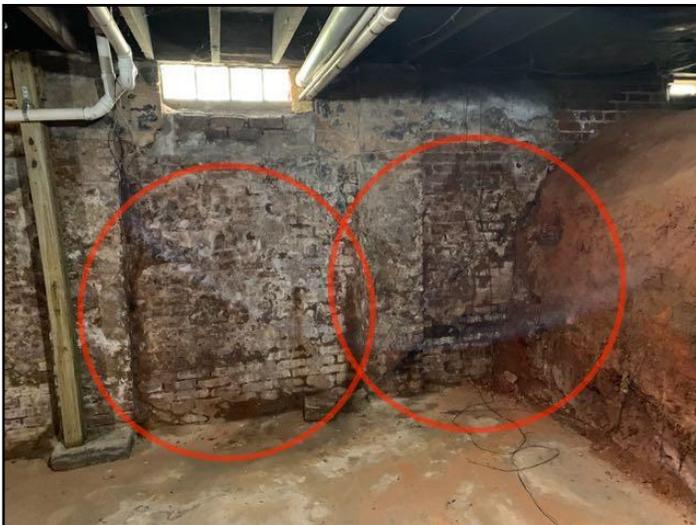
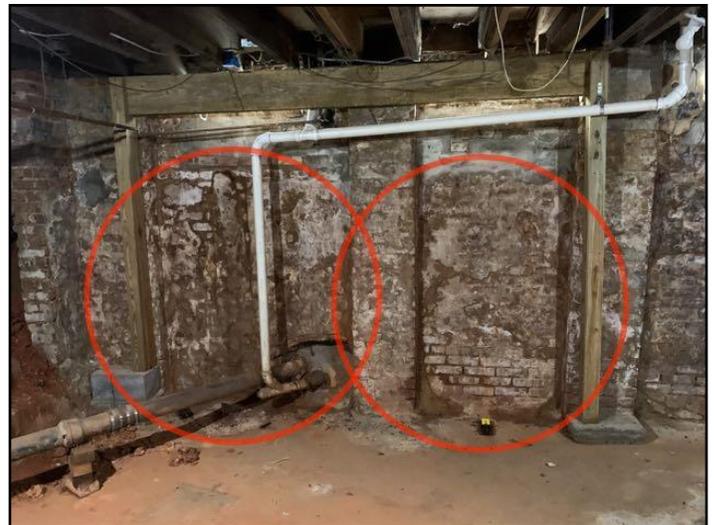
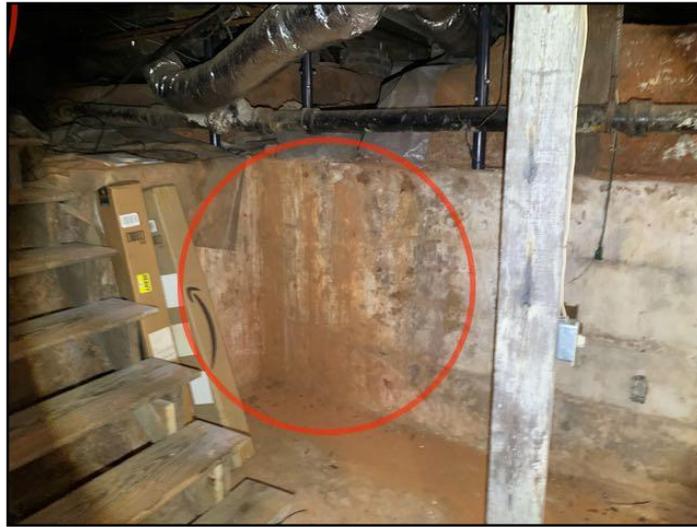
73. Condition: • [Dampness on floor or walls](#)

Task: Consult with a foundation or waterproofing company

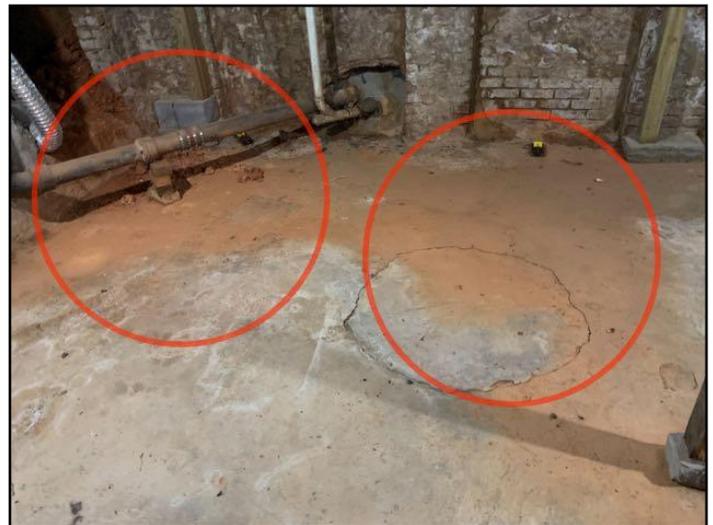
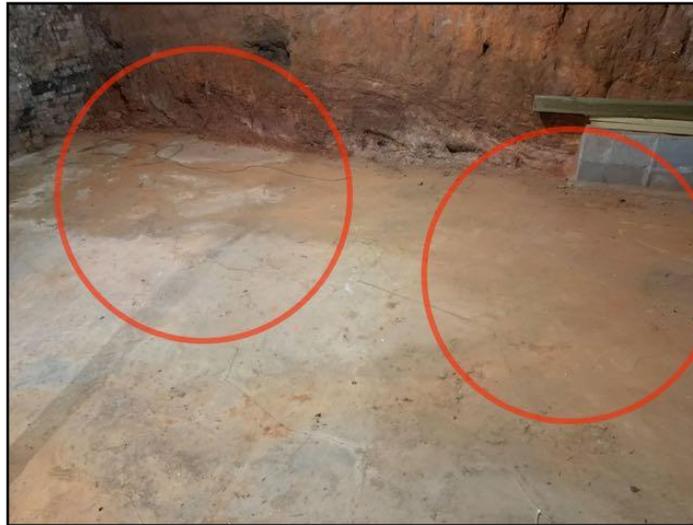
74. Condition: • [Water marks](#)

Task: Consult with a foundation or waterproofing company

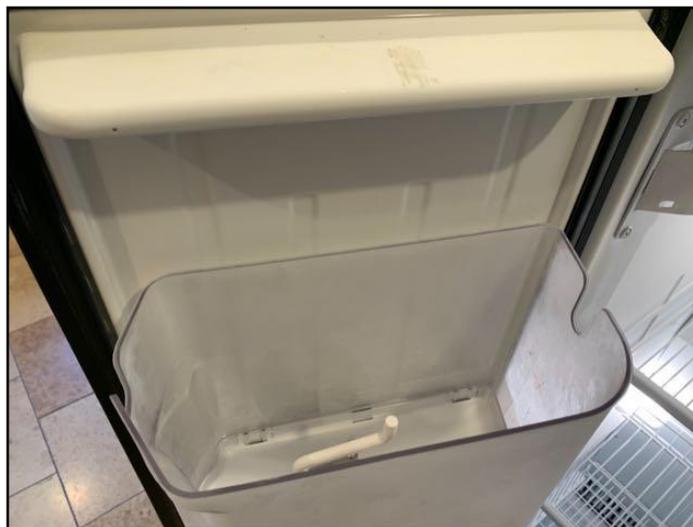
129. Refrigerator

75. Condition: • No Ice in Freezer Ice Maker

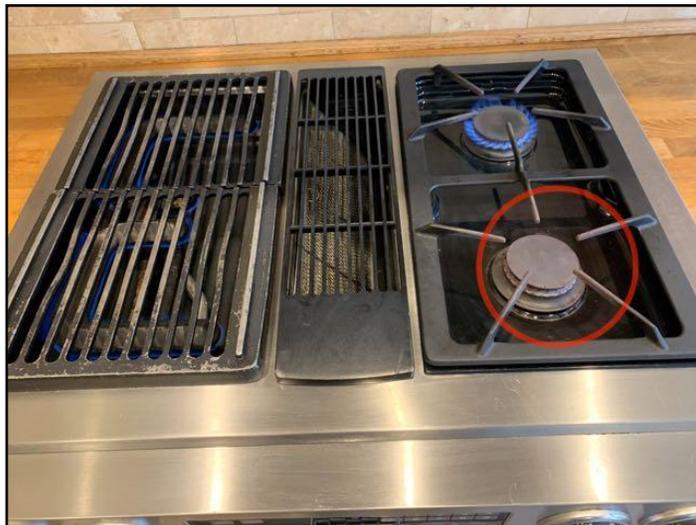
130. Range

76. Condition: • Burner/Elements inoperative

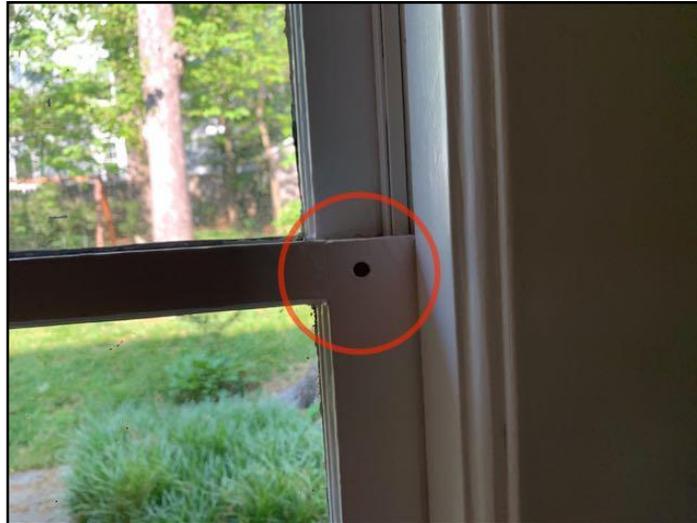
131.

Inspection limited/prevented by: • Most windows are pinned shut - This picture is representative

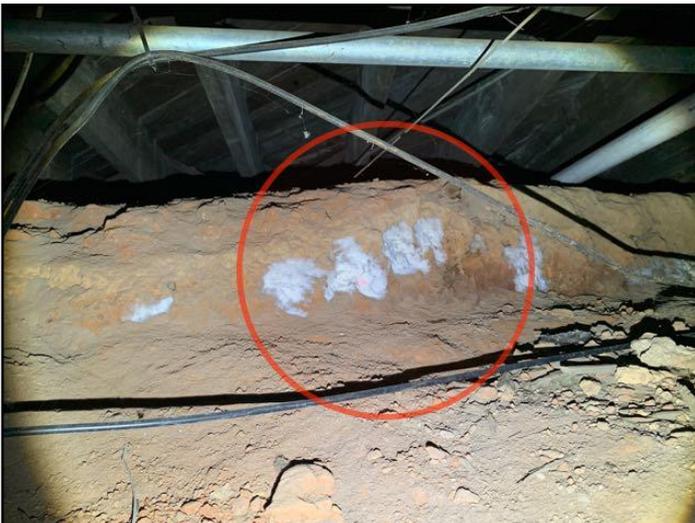
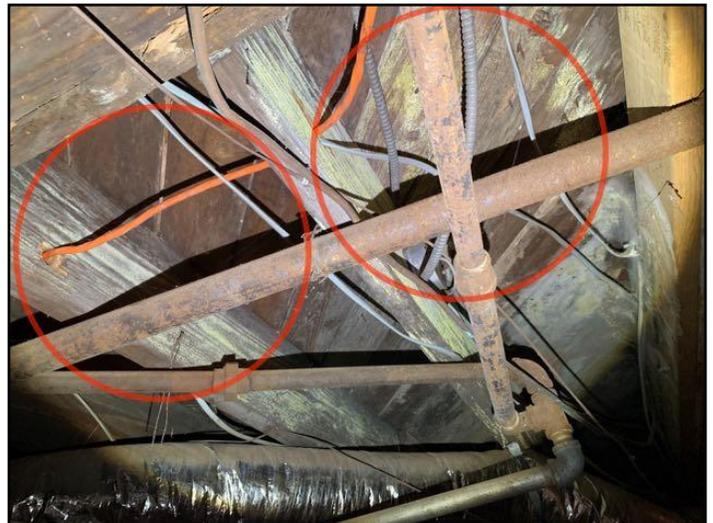
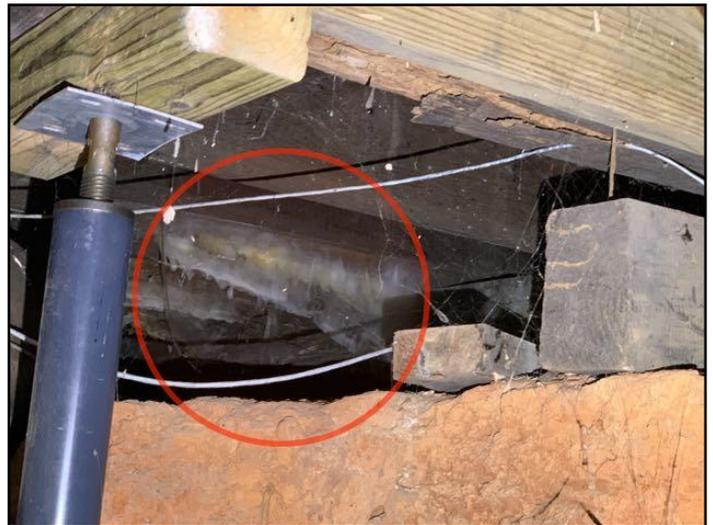
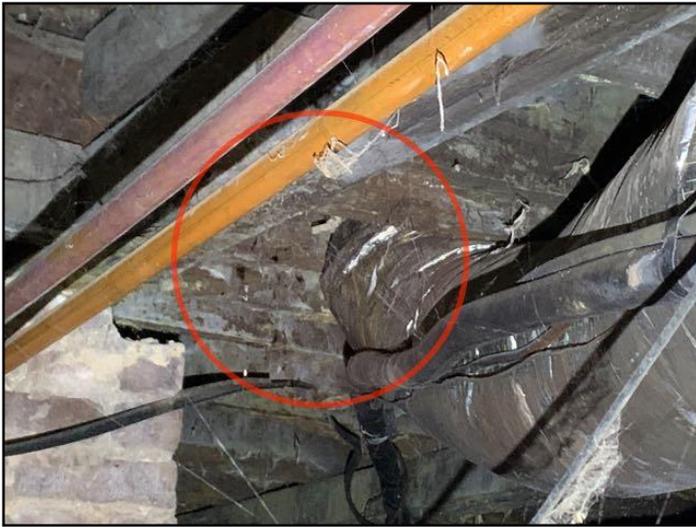
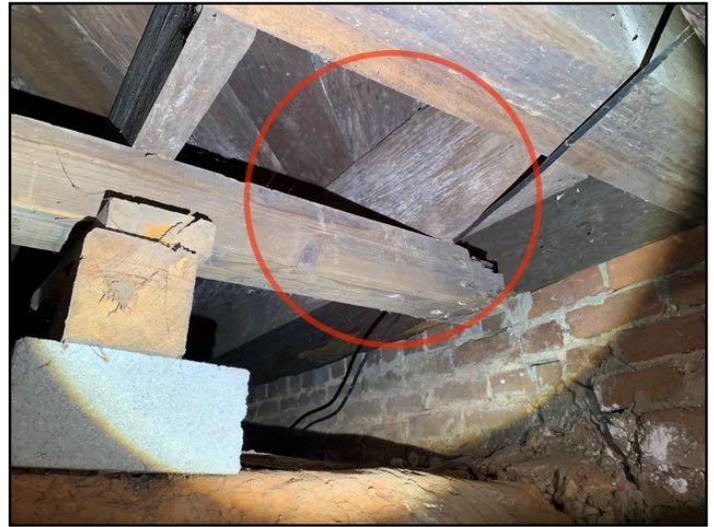
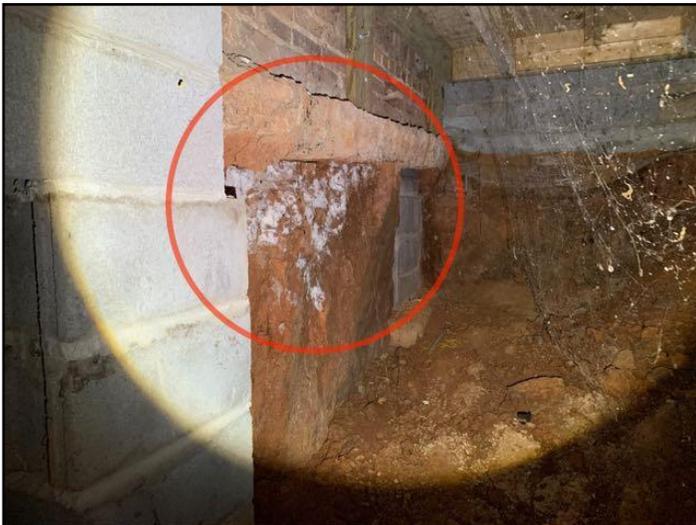
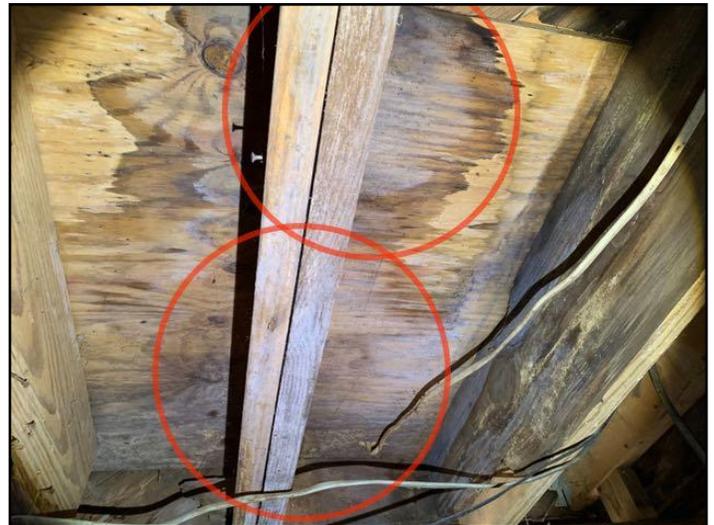
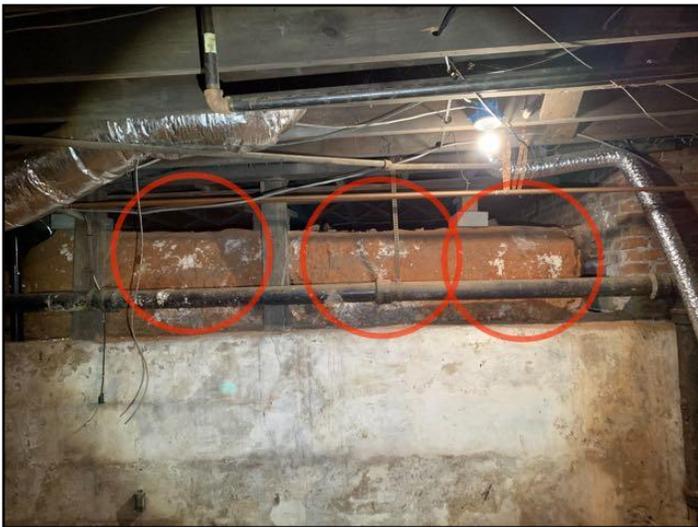
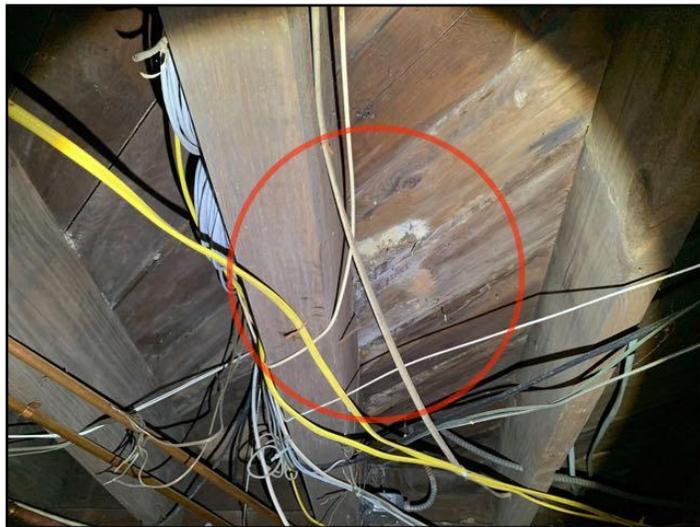
78. Condition: • Mold-like substance noted in Crawl

There is the presence of a mold-like substance on the interior of the home. Efforts are made to identify the specific areas of concern but it may be present in other areas not documented in this report as they may not be accessible and the growth may not be visible at the time of the inspection. This is usually an indication of an ongoing moisture issue or water intrusion problem. Mitigation will be required by an environmental company and water issues noted in the report will need to be corrected. This requires further evaluation by a specialist in this field as a home inspector is not trained for evaluating and reporting on any environmental hazard.
